Geraldton Fishing Boat Harbour

2022 Maintenance Dredging – Post-dredge Benthic Communities and Habitats

CLIENT: Mid West Ports Authority

REPORT NUMBER: R220108

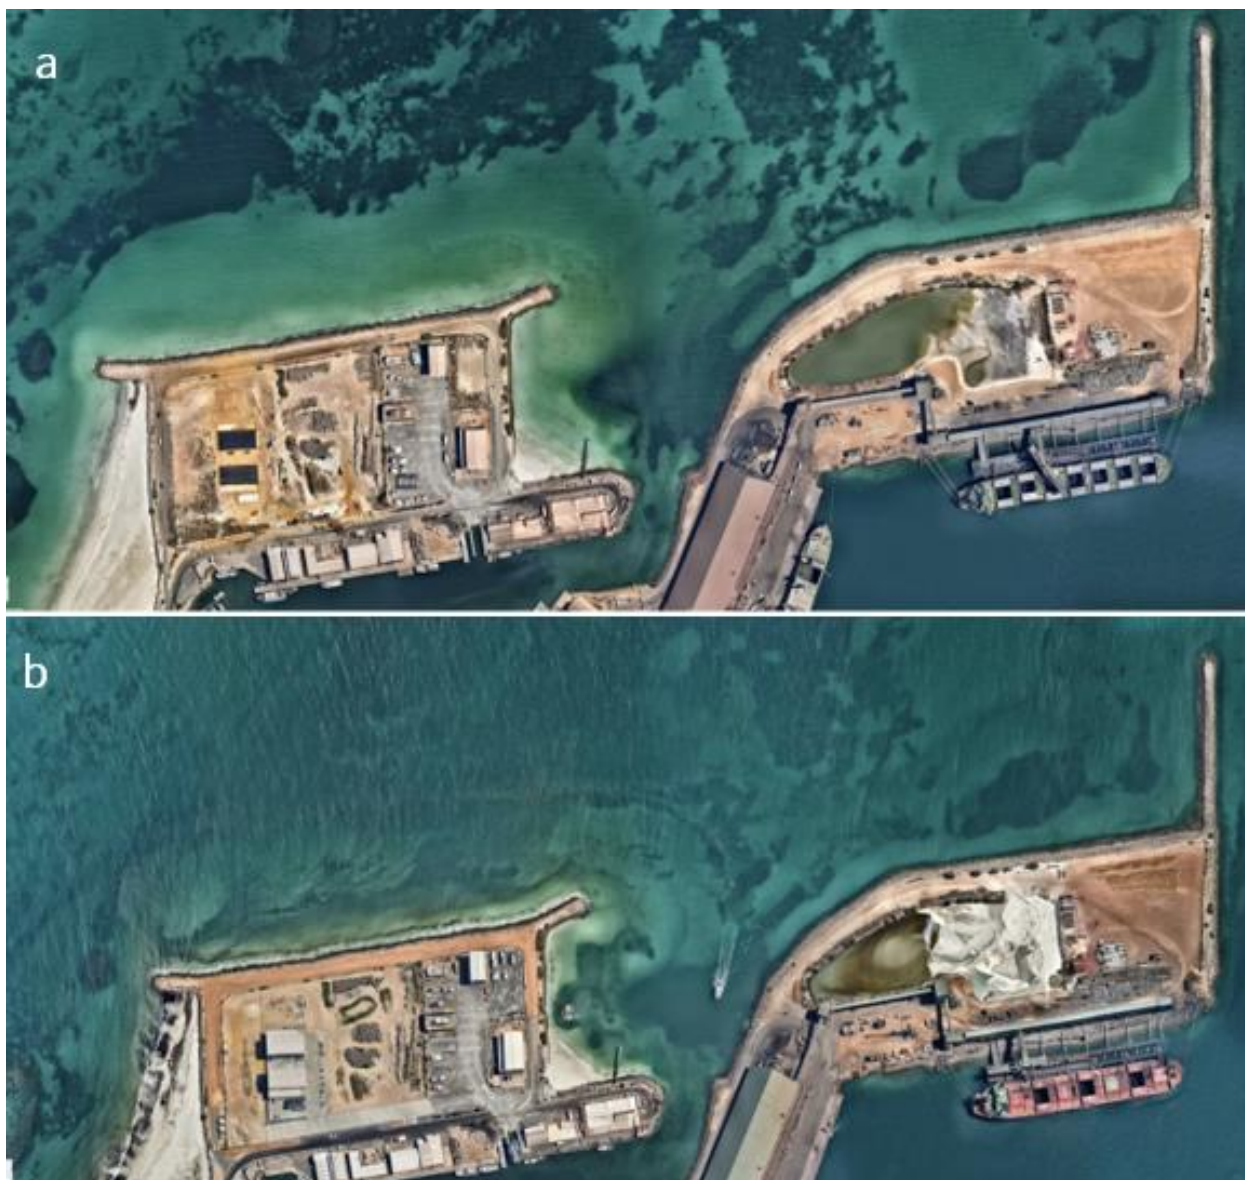
Figure 7 a) Pre dredge (February 2022), b) During dredging (December 2022)

Criteria was not reached. Plume sketches and aerial images confirm this. See below examples of aerial imagery (**Figure 7**, **Figure 8**, **Figure 9**) and plume sketch (**Figure 10**) captured during a period of continuous daily dredging during December 2022. **Figure 8** is a zoomed image of **Figure 7b**, revealing the minimal spatial extent of the dredge plume relative to nearby sensitive receptors. Site visits and visual inspections by MWPA during the project also validated that Performance Assessment Criteria 1 was not triggered.

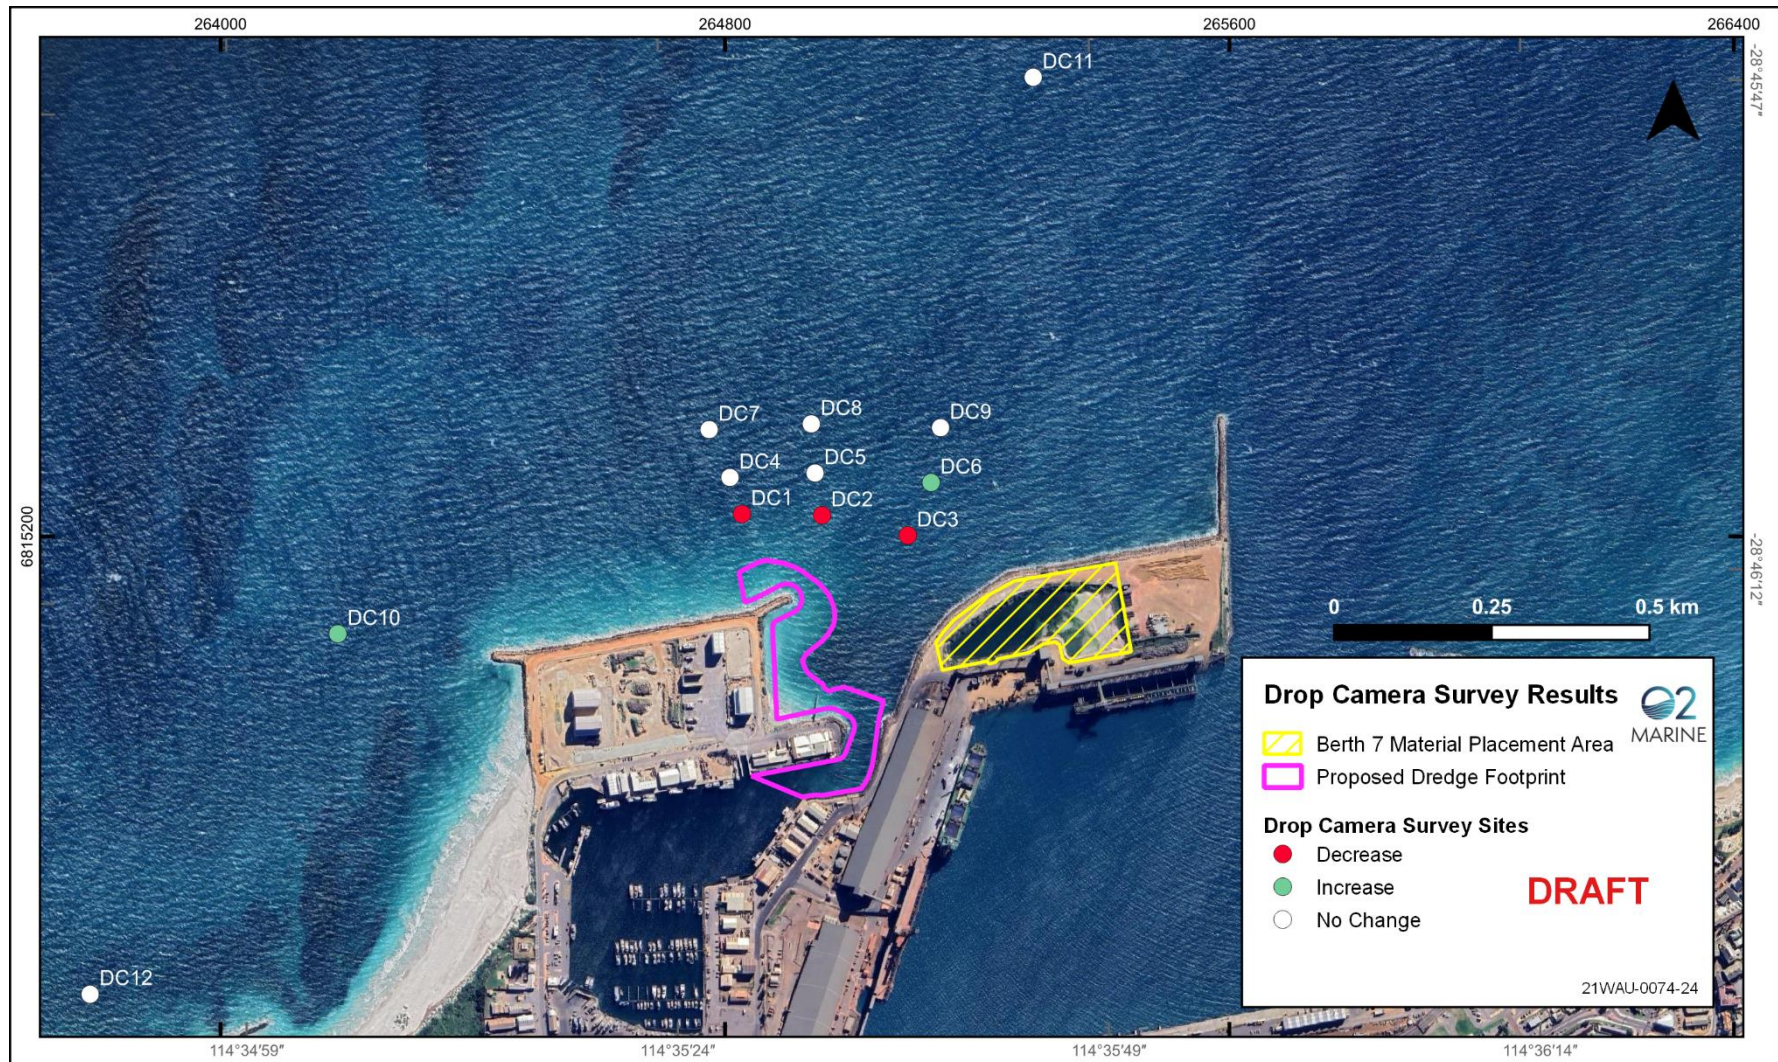
Figure 11 Results of BCH drop camera survey. Change in BCH total cover from pre-dredge survey to post-dredge survey.

The greatest observable reduction in BCH cover occurred at DC1, DC2 and DC3, sites located in closest proximity to the harbour entrance, and which were observed with varying levels of unattached wrack. The accumulation of wrack is likely attributed to natural processes. BCH mapping data in **Figure 6** reveals an abundance of shallow reefs southwest-west of the FBH, which may act as significant sources of macroalgal sea wrack under the dominant summer wind and sea conditions. During summer, SSW winds dominate this region, often reaching 46 km/h (Tecchiato et al., 2015). This wind drives north-eastward currents which may transport sea wrack, losing momentum as they reach the sheltered northern side of the FBH, where wrack can sink to the seabed. As a result, sea wrack may accumulate here during the summer months. This movement is evidenced in aerial imagery of the site collected in December (**Figure 7b**), where seagrass wrack can be observed along FBH reclamation area and on Pages beach. The accumulation of sea wrack can smother the remaining seagrass and facilitate a loss of sunlight possibly explaining the decline of seagrass cover at these sites.

Analysis of the post and pre-dredge BCH survey results revealed seagrass cover increases at two sites. Seven survey locations maintained high cover seagrass assemblages, including the addition of another seagrass taxa, *Syringodium spp.*, at two sites. Results showed increased macroalgae presence in three sites. Observed increases in seagrass cover and species richness are likely driven by seasonal variability, owing to the timings of the survey dates. During the pre-dredge survey (July), BCH productivity would have been low, a result of cooler water temperatures, more aggressive swell driven currents and increased turbidity which reduce the ability for BCH to grow (Masini & Manning 1997, Lavery et al 2009). The post-dredge survey (February) took place during the summer months, which typically features warmer waters, less aggressive currents and lower
