## 2021 ASSESSMENT OF POTENTIAL DREDGE MATERIAL PLACEMENT AREAS WITHIN CHAMPION BAY, WA

# Assessment of Potential Dredge Material Placement Areas within Champion Bay WA

Reference: R-10708-1  
Date: July 2021  
Confidential

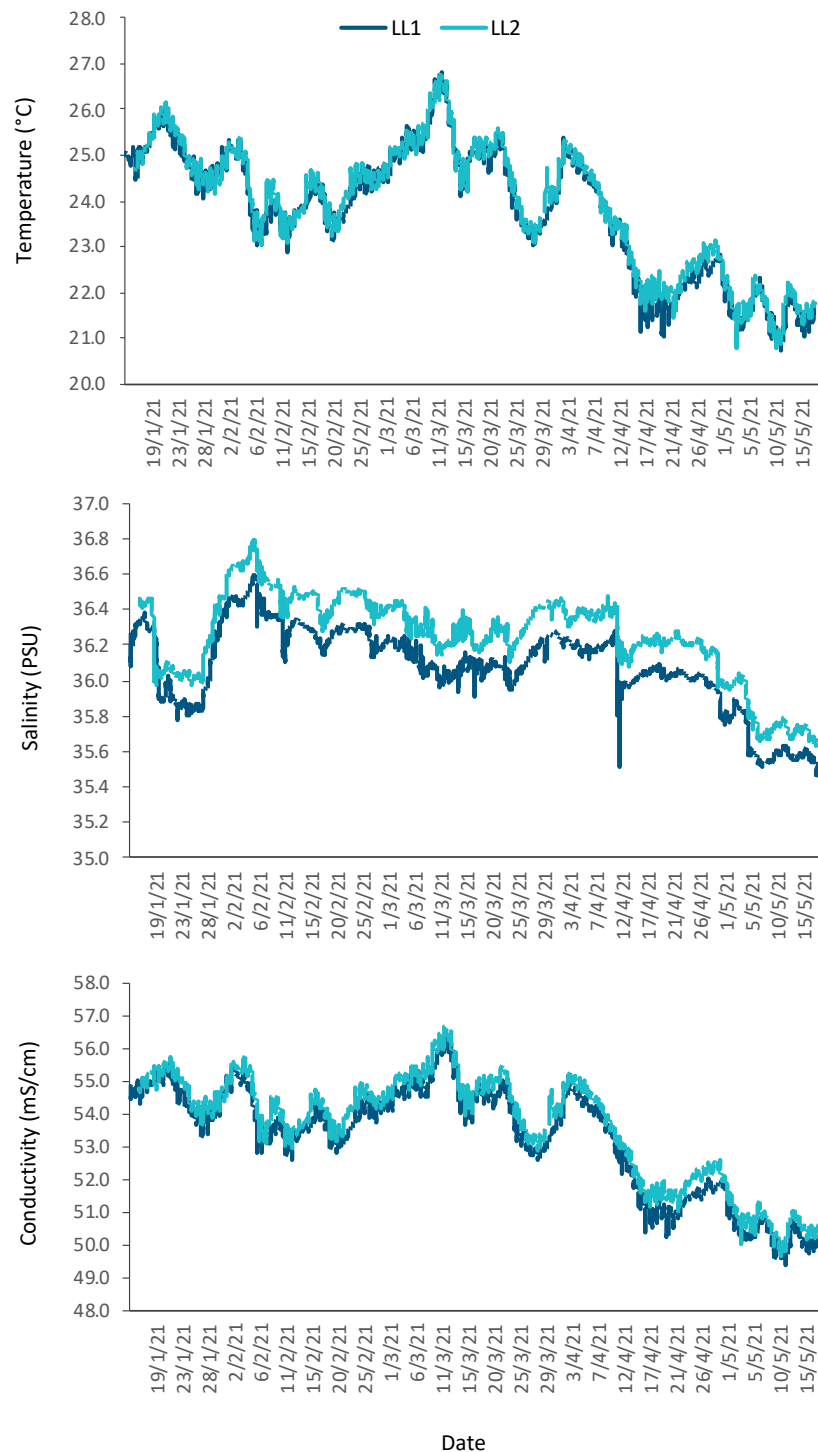
Figure 3-7 Daily measurements of temperature, salinity and conductivity at sites LL1 and LL2

Temperature, salinity and conductivity at sites LL1 and LL2 varied on a daily basis but gradually declined over the ~four months (Figure 3-7). Water temperature near the seagrass meadows (~0.5 m above seabed) ranged from 20.71–26.82°C at sites LL1 and LL2, with lower temperatures recorded during mid-April to May 2021 (Figure 3-7; Table 3-2). Temperature readings were almost identical at both sites (Figure 3-7; Table 3-2).

Site LL1 recorded slightly lower salinity and conductivity levels than site LL2, with slightly lower levels measured at the end of deployment period (mid-April to May; Figure 3-7).

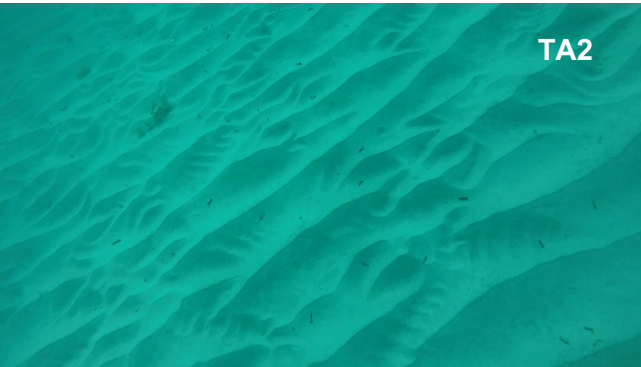
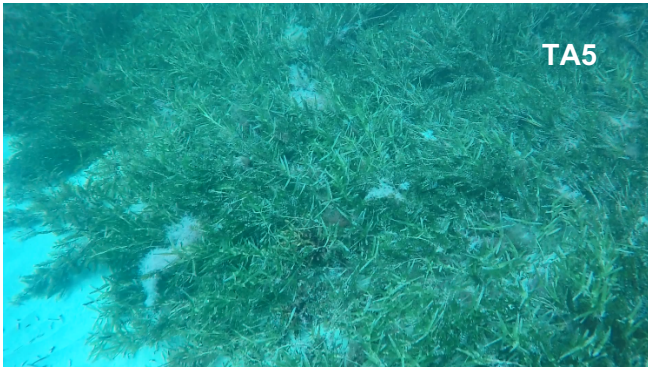
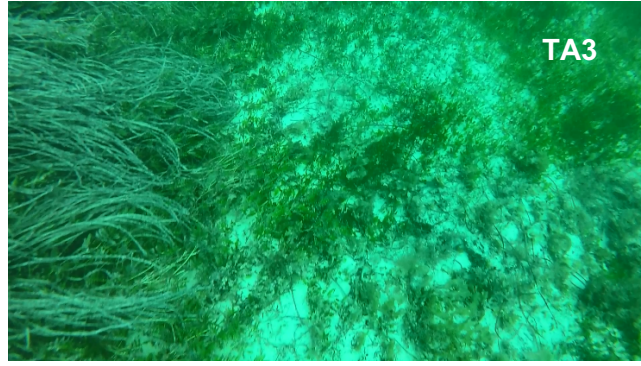
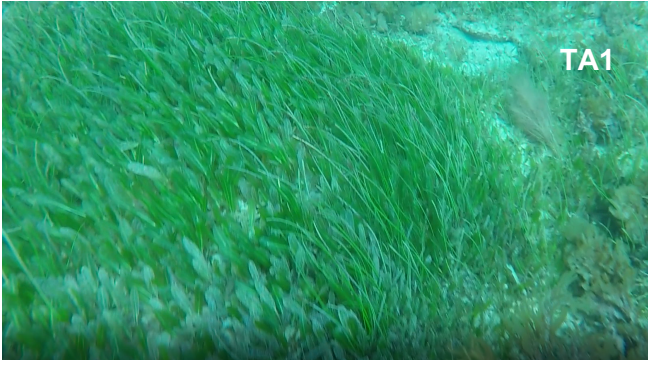
Location	Dominant benthic habitat categories	Example images of benthic habitat categories	
Within Placement Site A (TA1–TA6)	Bare sand (top left)

<i>A. antarctica</i> , <i>A. griffithii</i> (top right), <i>T. pachyrrhizum</i> , <i>P. sinuosa</i> (middle left), <i>Halophila</i> spp. (middle right), and <i>S. isoetifolium</i>		
	<i>Sargassum</i> spp., <i>Ecklonia</i> spp., <i>Padina</i> spp., and other brown algae (bottom left, bottom right) on low relief reefs (<1 m)

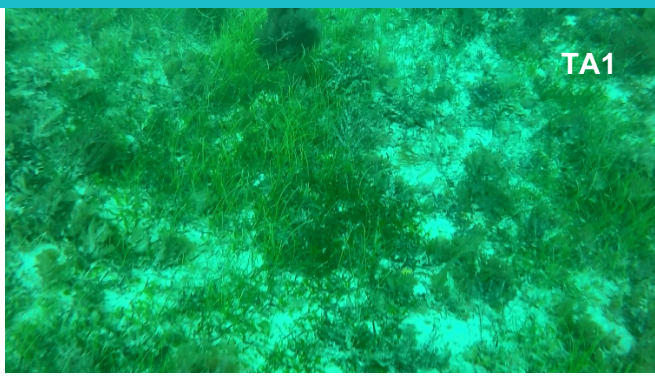
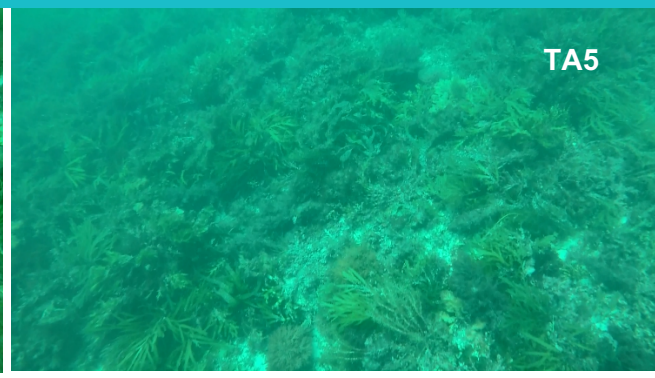
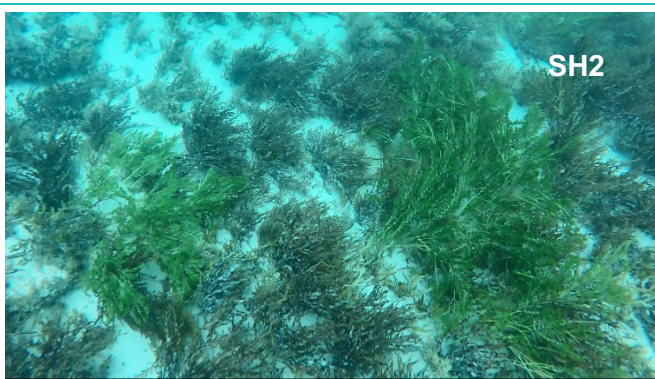
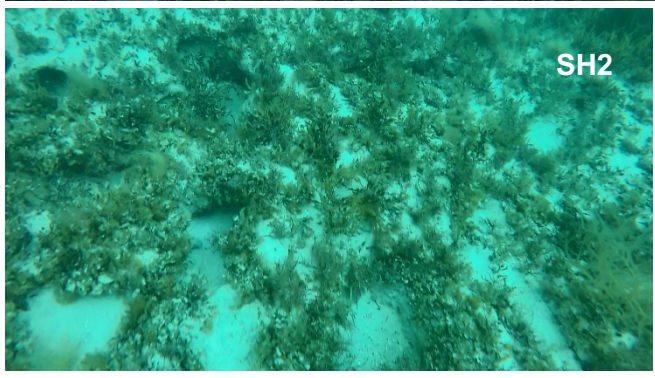
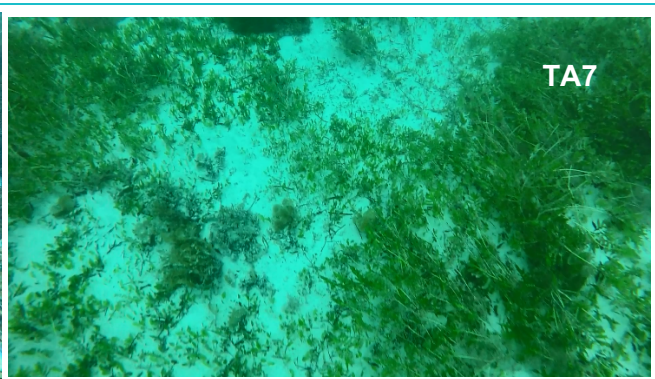
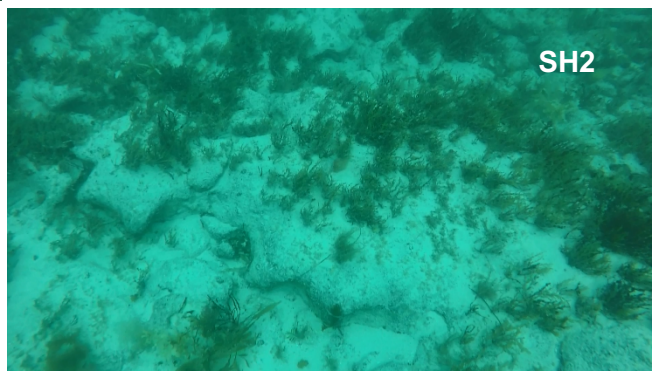
Adjacent to Placement Site A (TA7, SH2)	<p><i>A. antarctica</i> (top left), <i>A. griffithii</i>, <i>S. isoetifolium</i> (top right), and <i>Halophila</i> spp.</p> <p><i>Sargassum</i> spp., <i>Ecklonia</i> spp., and brown curly macroalgae on low relief reef (&lt;1 m; bottom left, bottom right)</p>

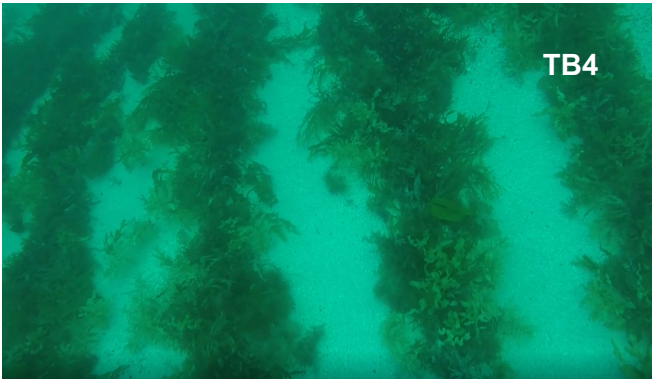
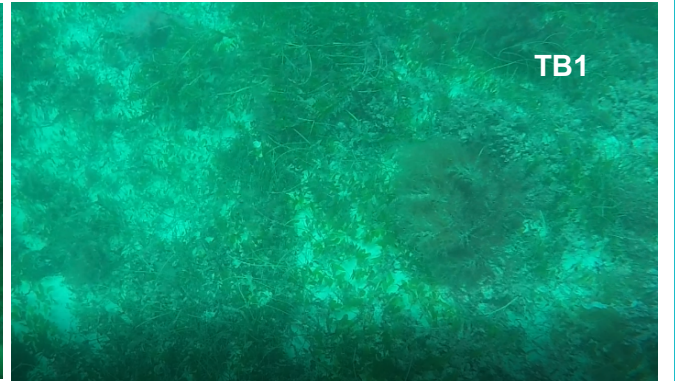
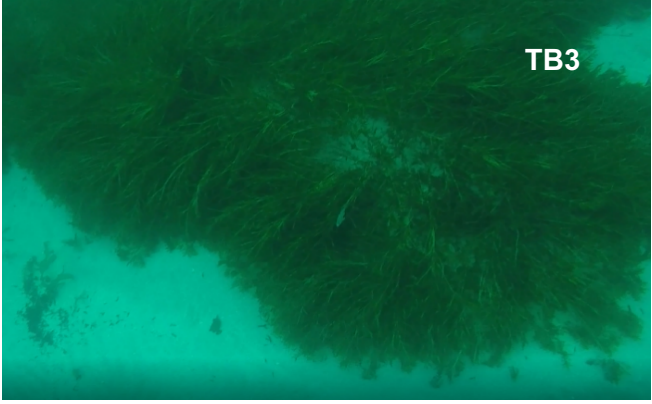
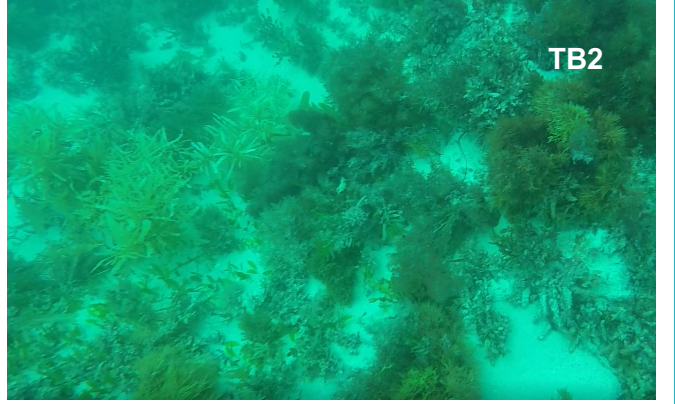
Location	Dominant benthic habitat categories	Example images of benthic habitat categories	
Within Placement Site B (TB1–TB5)	<p>Bare sand with wrack (top left)</p> <p><i>Halophila</i> spp., (top right), <i>A. antarctica</i> (bottom left), <i>A. griffithii</i>, <i>T. pachyrhizum</i>, and <i>S. isoetifolium</i></p> <p><i>Sargassum</i> spp. (bottom right), <i>Ecklonia</i> spp. on low relief reef (&lt;1 m)</p>

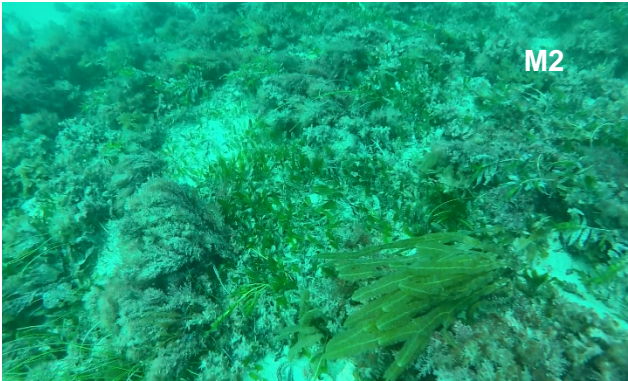
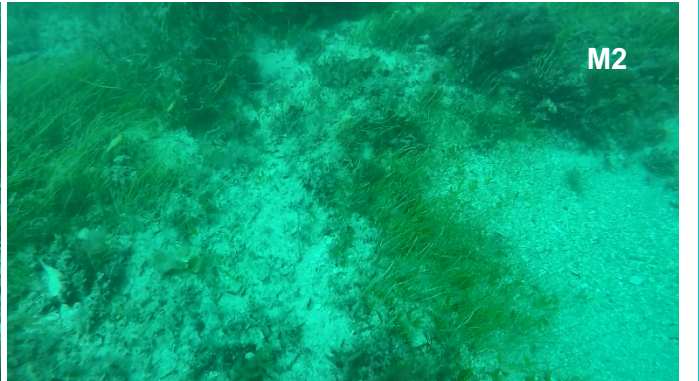
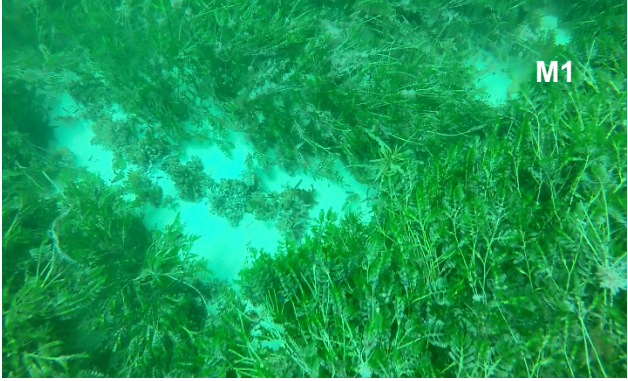
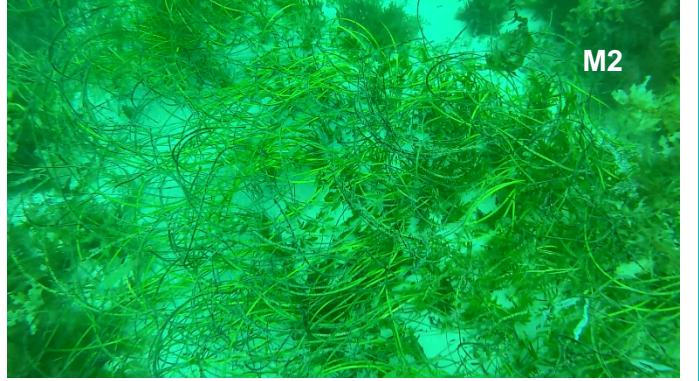
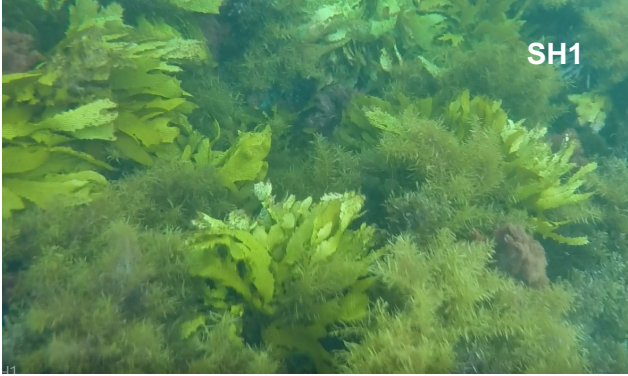
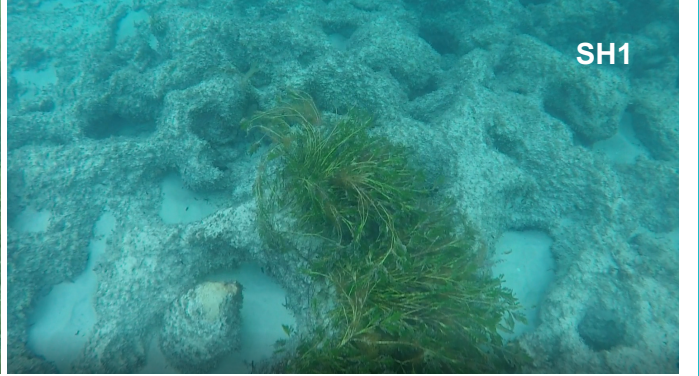
Location	Dominant benthic habitat categories	Example images of benthic habitat categories	
Adjacent to Placement Site B (M1, M2, SH1)	<p><i>A. antarctica</i> (middle left, bottom right), <i>A. griffithii</i>, <i>Halophila</i> spp. (top left), <i>S. isoetifolium</i> (top right), <i>P. coriacea</i> (middle right), and <i>P. sinuosa</i></p> <p><i>Sargassum</i> spp., <i>Dictyopteris</i> spp., <i>Ecklonia</i> spp. (bottom left) on low (&lt;1 m; bottom right) and medium relief reef (1–4 m)</p>

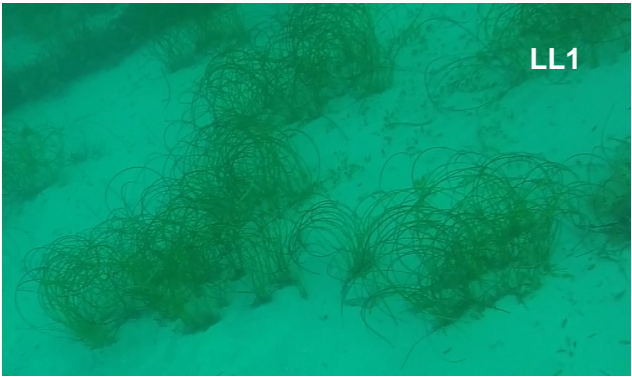
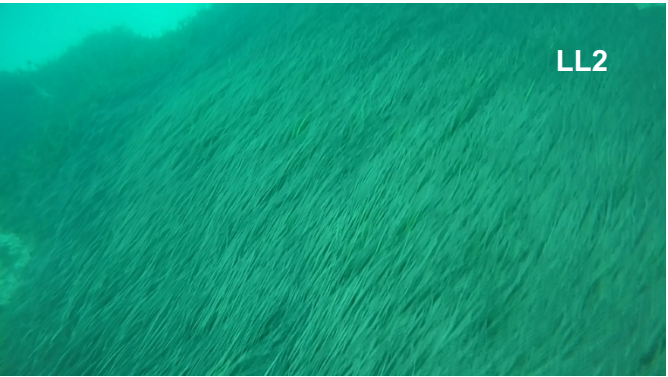
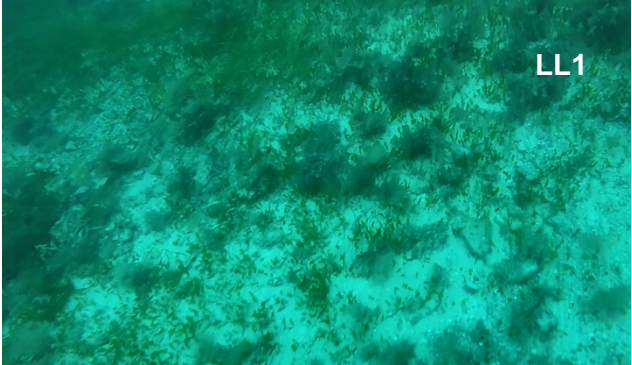
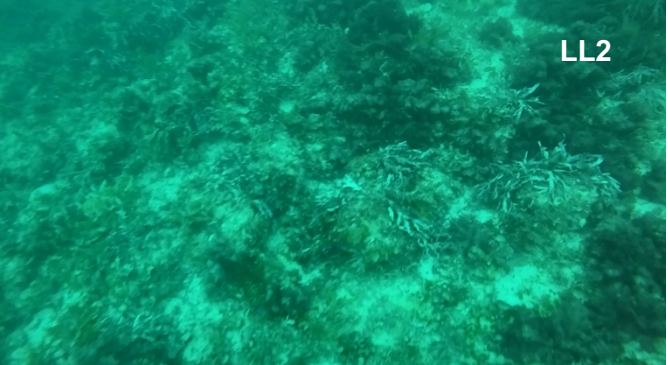
Location	Dominant benthic habitat categories	Example images of benthic habitat categories	
Other adjacent transects (LL1*, LL2*)	<i>P. coriacea</i> (top left), <i>P. sinuosa</i> (top right), <i>A. antarctica</i> , <i>S. isoetifolium</i> , and <i>Halophila</i> spp. (bottom left) over bare sand and on low relief reef (<1 m)

LL2
	Low relief reef (<1 m) with mixed macroalgae community (bottom right)

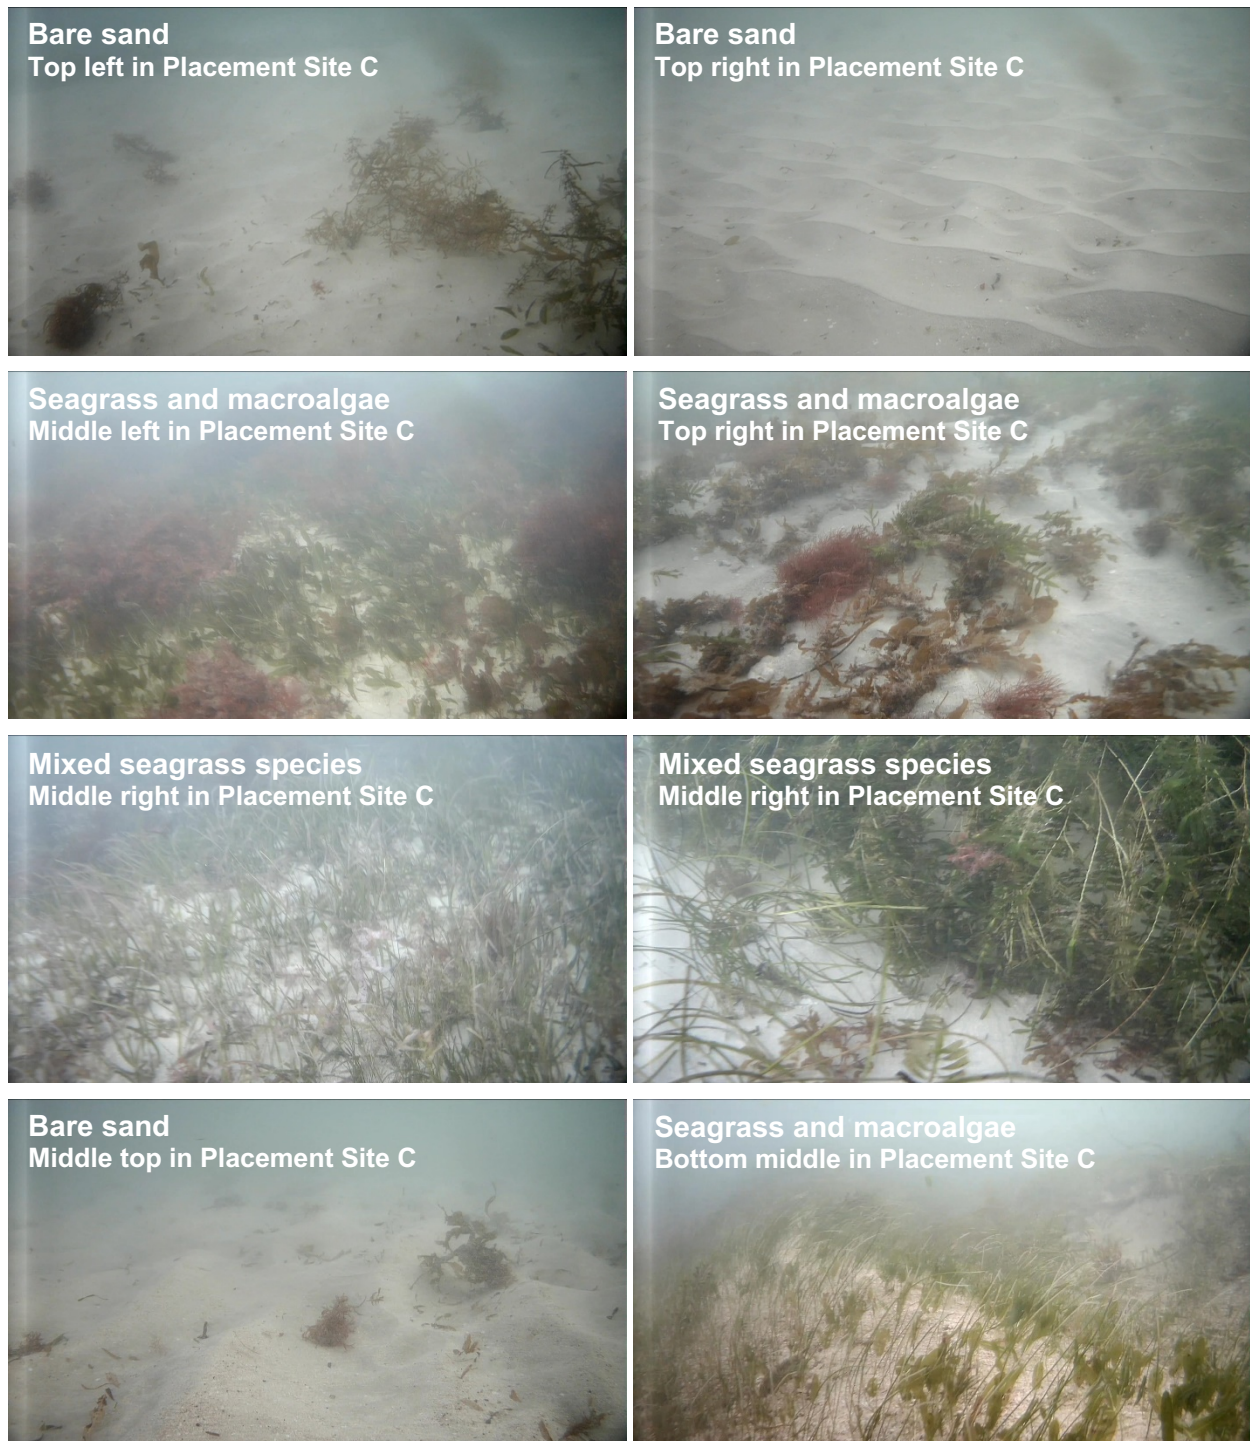
**Figure 3-3 Drop down camera images of benthic habitat in Placement Site C**

The benthic habitat of Placement Site C consisted of unconsolidated sediments with few areas of low relief reef (<1 m). Benthic communities were largely dominated by mixed seagrasses and macroalgae (seagrass habitat identified in 62% of captured still images; Figure 3-1; Figure 3-3). The seagrasses identified throughout Placement Site C included *Posidonia sinuosa*, *Amphibolis antarctica*, *A. griffithii*, *Halophila* spp. and *Syringodium isoetifolium* (Figure 3-3). The macroalgae growing on low relief reefs were *Sargassum* spp., *Ecklonia* spp., *Padina* spp. and other brown and red algae. Dense meadows of *A. antarctica* were recorded in sections of drop-camera images (Figure 3-1) in Placement Site C. Furthermore, *S. isoetifolium* and *Halophila* spp. were present in 38% of all 21 sites analysed in Placement Site C, with dense meadows of both species identified in sections of drop-camera images (Figure 3-1). The sections of bare sand observed throughout Placement Site C were either flat (no profile) or contained small ripples with undulations 1–10 cm (Figure 3-1; Figure 3-3).
