Geraldton Fishing Boat Harbour

2022 Maintenance Dredging – Post-dredge Benthic Communities and Habitats

CLIENT: Mid West Ports Authority

REPORT NUMBER: R220108

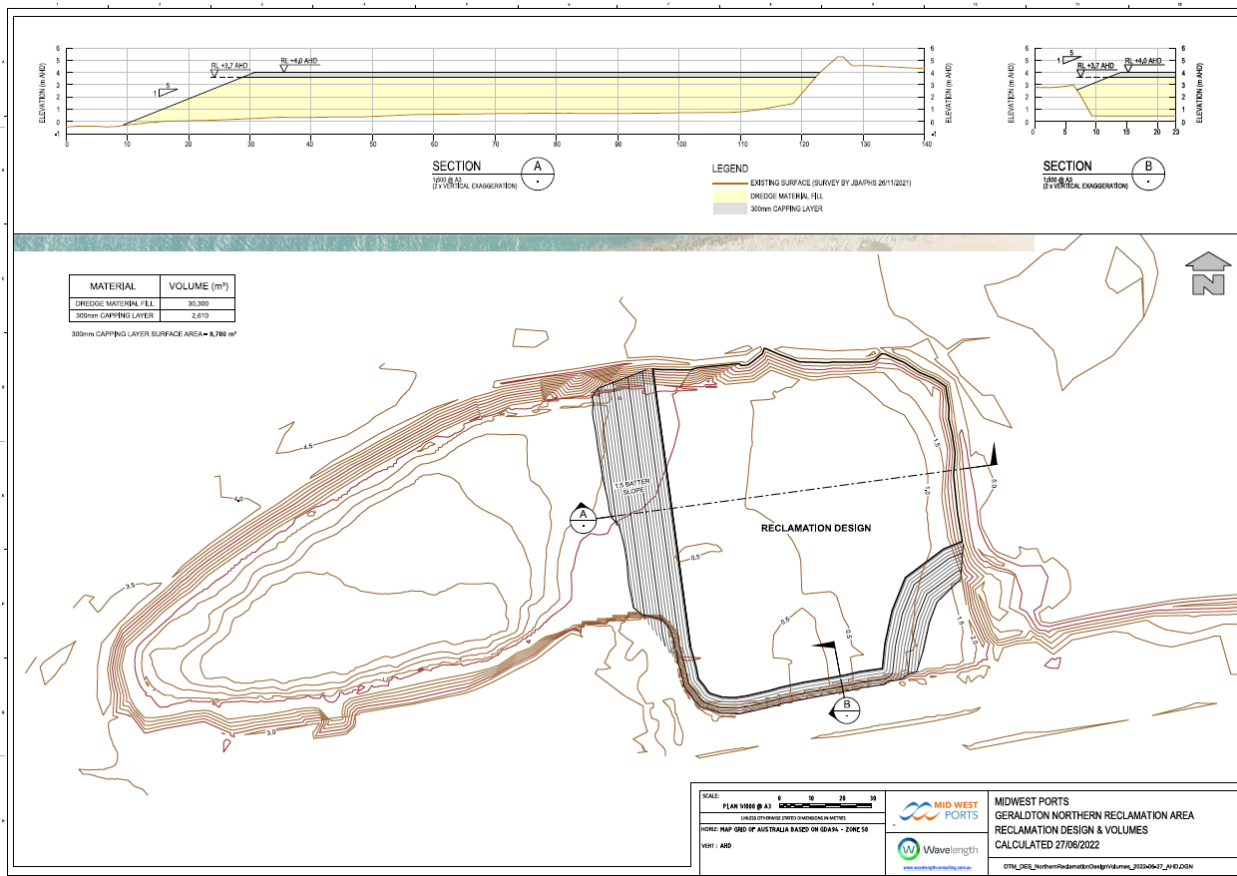
Figure 4 Berth 7 Dredge Material Placement Area and Tailwater Return Pipes

The location of the dredge discharge pipeline within the DMPA was varied over the duration of the dredging to allow for the even placement of sediments within the area (**Figure 4**). Excess water ('tailwater') returned to the northwest corner of the harbour via existing return water outlet pipes located in the south-western corner of the reclamation area (**Figure 4** and **Figure 5**). A geotextile silt curtain will be installed within the reclamation area prior to the outlet pipes to minimise fine sediment release to the Harbour.

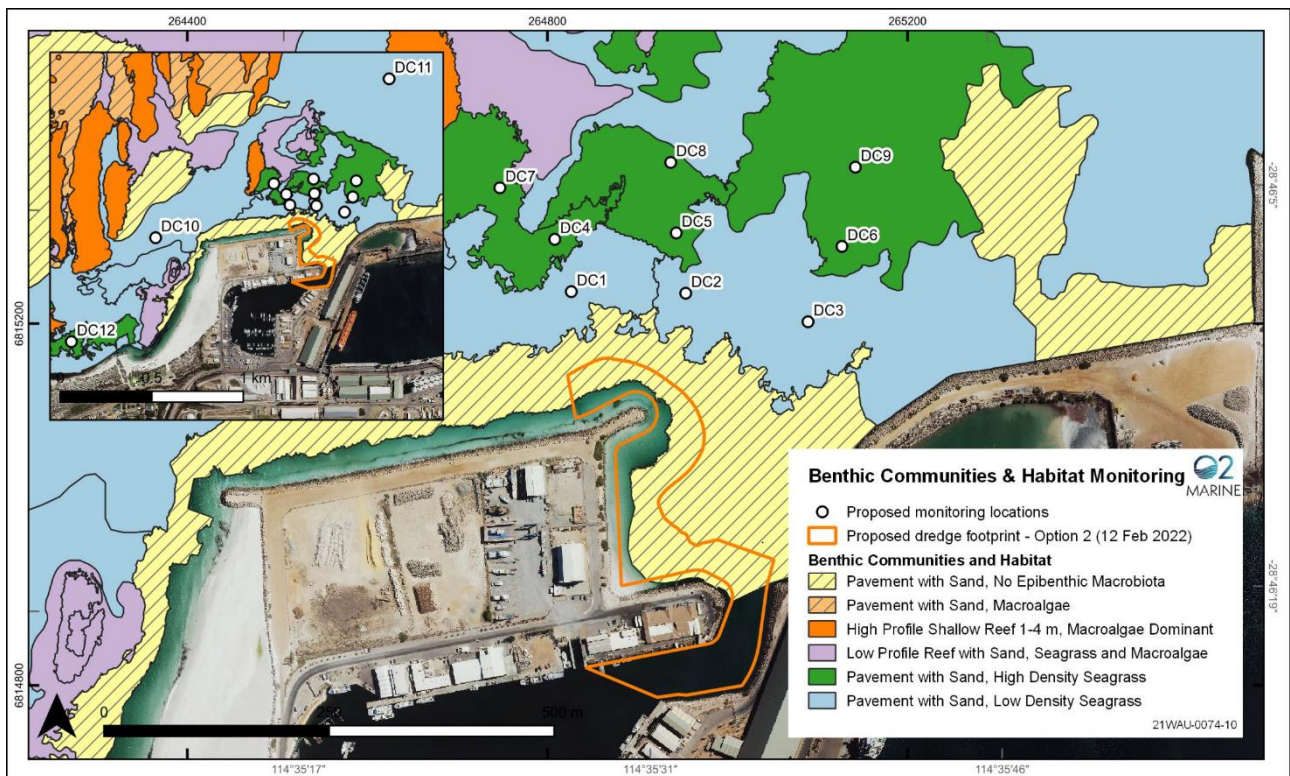
Figure 6 Pre- and post-dredge BCH survey effort and study locations

The greatest observable reduction in BCH cover occurred at DC1, DC2 and DC3, sites located in closest proximity to the harbour entrance, and which were observed with varying levels of unattached wrack. The accumulation of wrack is likely attributed to natural processes. BCH mapping data in **Figure 6** reveals an abundance of shallow reefs southwest-west of the FBH, which may act as significant sources of macroalgal sea wrack under the dominant summer wind and sea conditions. During summer, SSW winds dominate this region, often reaching 46 km/h (Tecchiato et al., 2015). This wind drives north-eastward currents which may transport sea wrack, losing momentum as they reach the sheltered northern side of the FBH, where wrack can sink to the seabed. As a result, sea wrack may accumulate here during the summer months. This movement is evidenced in aerial imagery of the site collected in December (**Figure 7b**), where seagrass wrack can be observed along FBH reclamation area and on Pages beach. The accumulation of sea wrack can smother the remaining seagrass and facilitate a loss of sunlight possibly explaining the decline of seagrass cover at these sites.

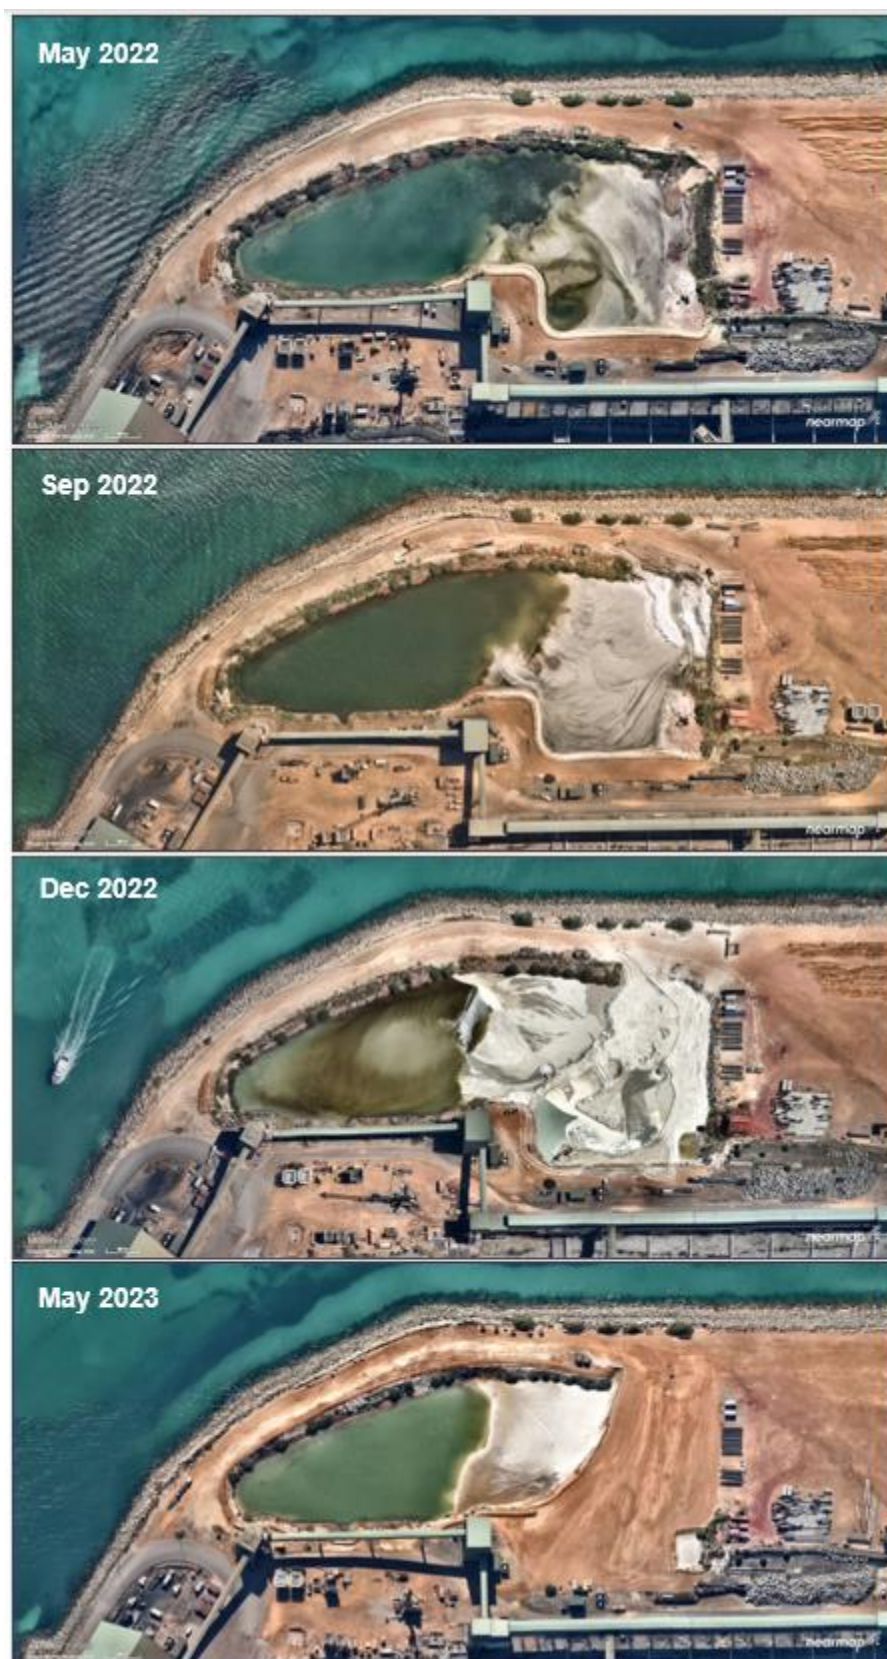
Figure 9 Aerial imagery of Berth 7 at various stages of the dredging program: Before (May), During (September, December), After (May 2023).

Criteria was not reached. Plume sketches and aerial images confirm this. See below examples of aerial imagery (**Figure 7**, **Figure 8**, **Figure 9**) and plume sketch (**Figure 10**) captured during a period of continuous daily dredging during December 2022. **Figure 8** is a zoomed image of **Figure 7b**, revealing the minimal spatial extent of the dredge plume relative to nearby sensitive receptors. Site visits and visual inspections by MWPA during the project also validated that Performance Assessment Criteria 1 was not triggered.
