AUGUST 2024

Annual Environmental Report

Prepared By:
Mid West Ports

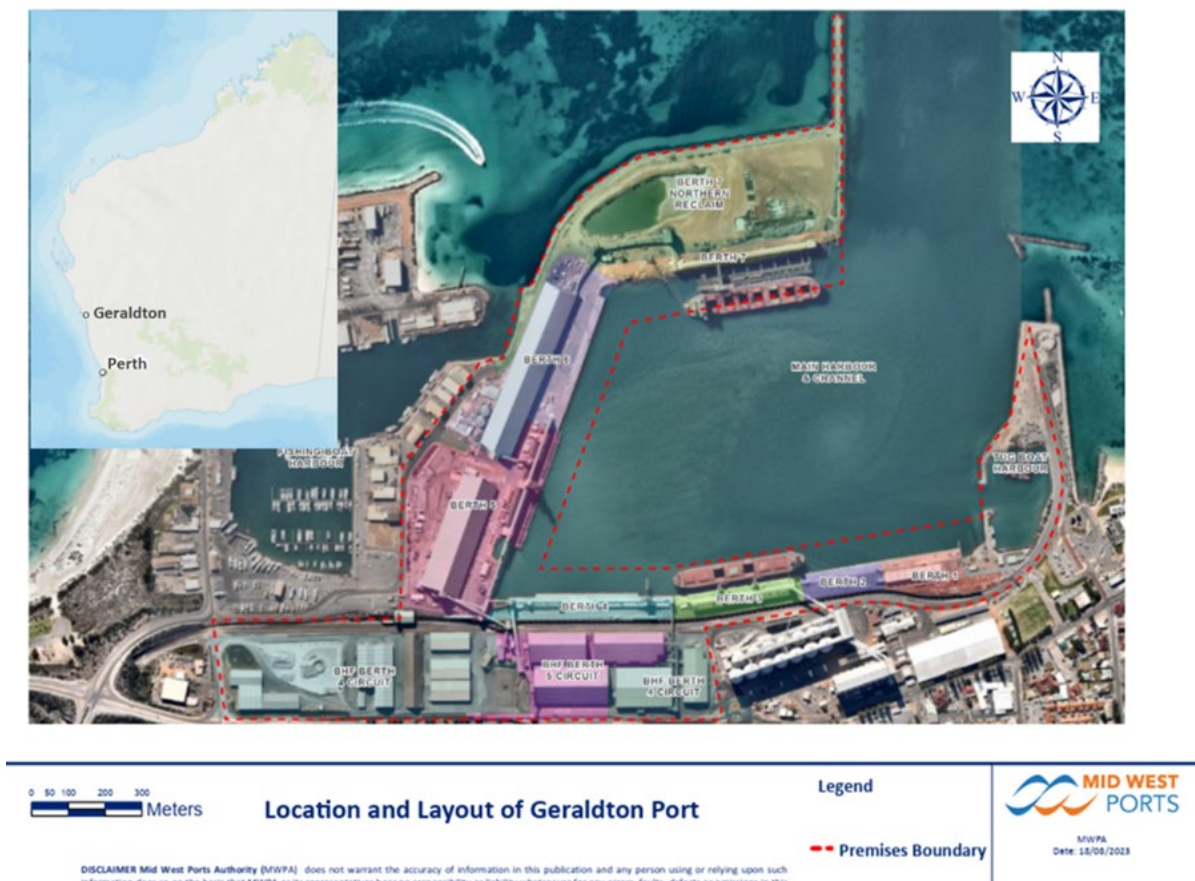
Figure 1 – Location and Layout of Geraldton Port

The Geraldton Port (the Port) is situated in the Mid West region of Western Australia, approximately 430km north of Perth. Geraldton is the major hub for the region and services the mining, agricultural and fishing industries. The Port consists of a Commercial Harbour comprised of seven bulk loading berths, as well as a Fishing Boat Harbour (FBH). Figure 1 shows the location and layout of the Port.

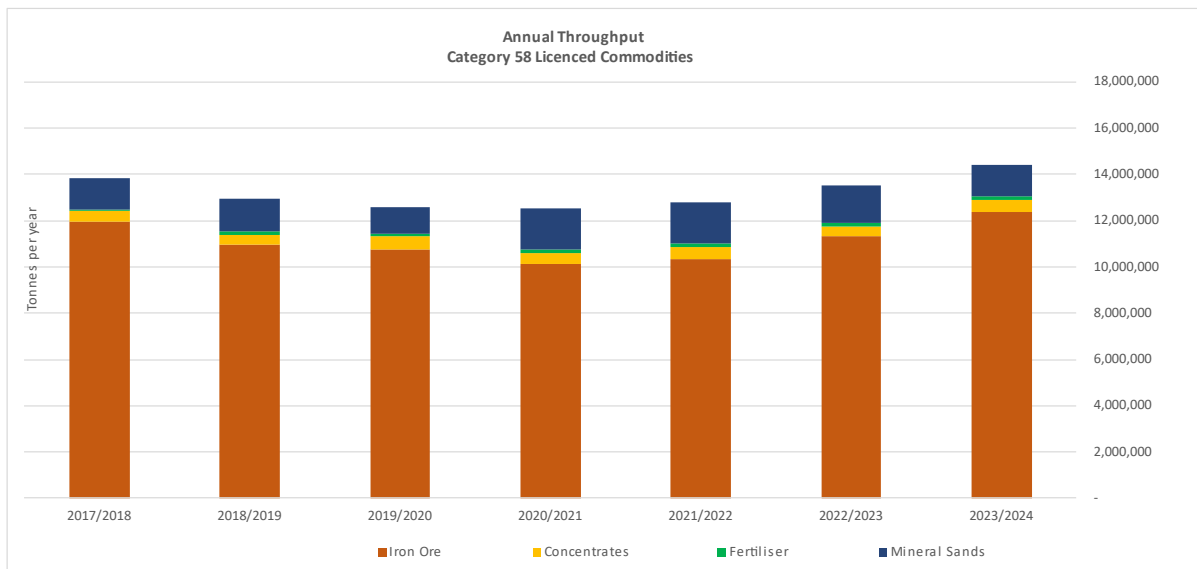
Figure 2 – Geraldton Port Annual Throughput by Commodity

Figure 2 provides a summary of annual throughput by Category 58 licenced commodity.

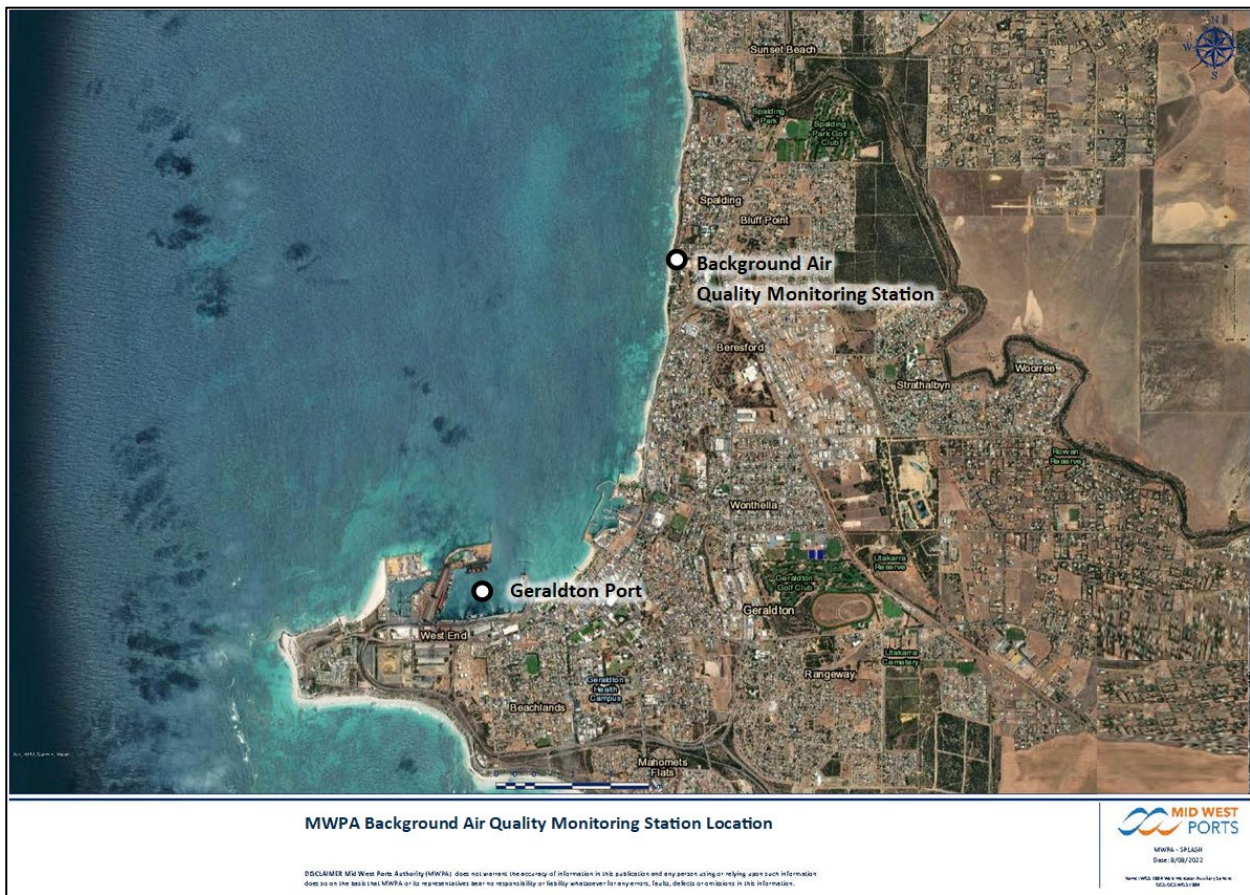
Figure 4 - MWPA Background Air Quality Monitoring Location

To better understand typical background dust levels commensurate with the Port’s location, MWPA installed a real time PM₁₀ Beta Attenuation Monitor (BAM1020) in late 2013. The BAM is located approximately 4km north of the Port in the suburb of Bluff Point (Figure 4). This location was selected as the weather, vegetation and soil characteristics are proportionate with those experienced at the Port. It is positioned at a similar distance to the ocean, which may influence PM₁₀ concentrations through sea spray and salt. This site is referred to as Background BAM (BB) for the remainder of this report.

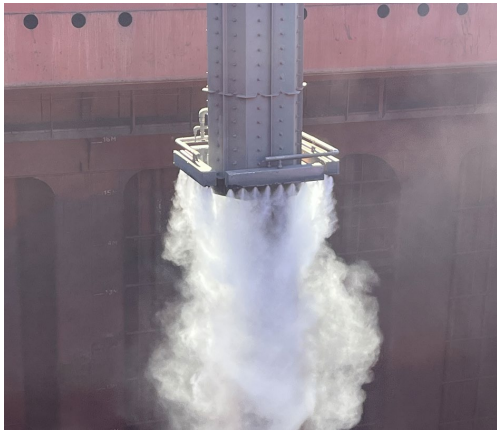
Berth 5 Shiploader Dry Fog System

Figure 5 - Dust Improvements Implemented

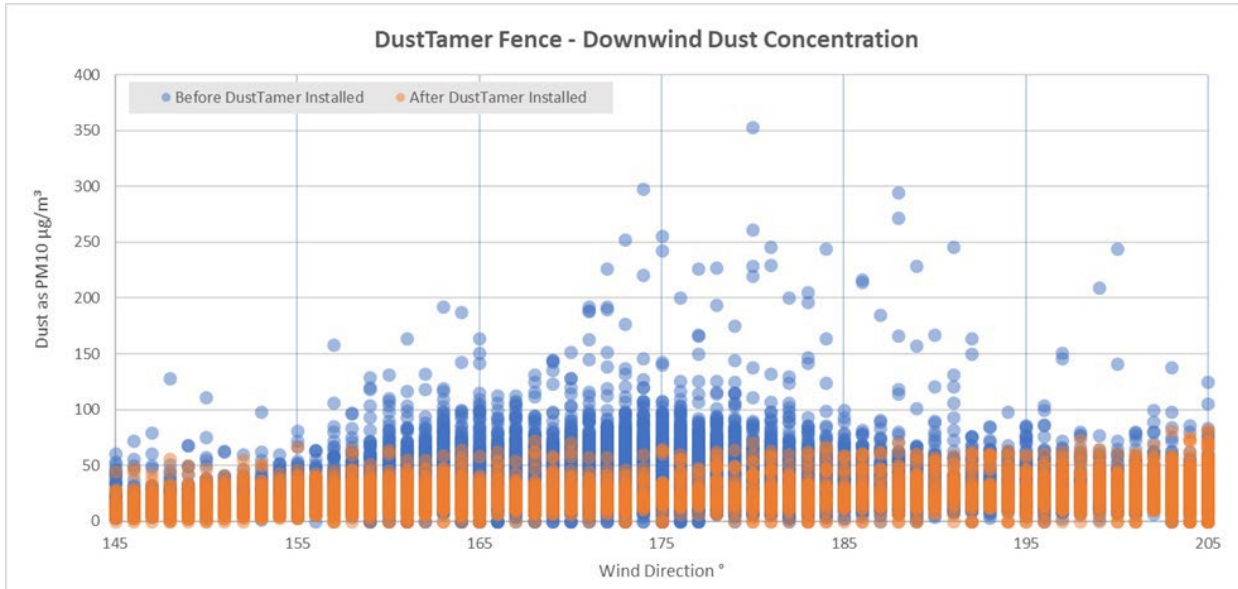
A DustTamer fence was constructed on Marine Terrace in April 2023, significantly improving air quality downwind of the fence in the Fishing Boat Harbour, as shown in Figure 6. Data from e-samplers upwind and downwind of the fence demonstrates that peak PM10 concentrations have largely been eliminated and the concentrations have reduced by 50% overall under southerly wind conditions.

Figure 6 – DustTamer Fence – Downwind Dust Concentrations

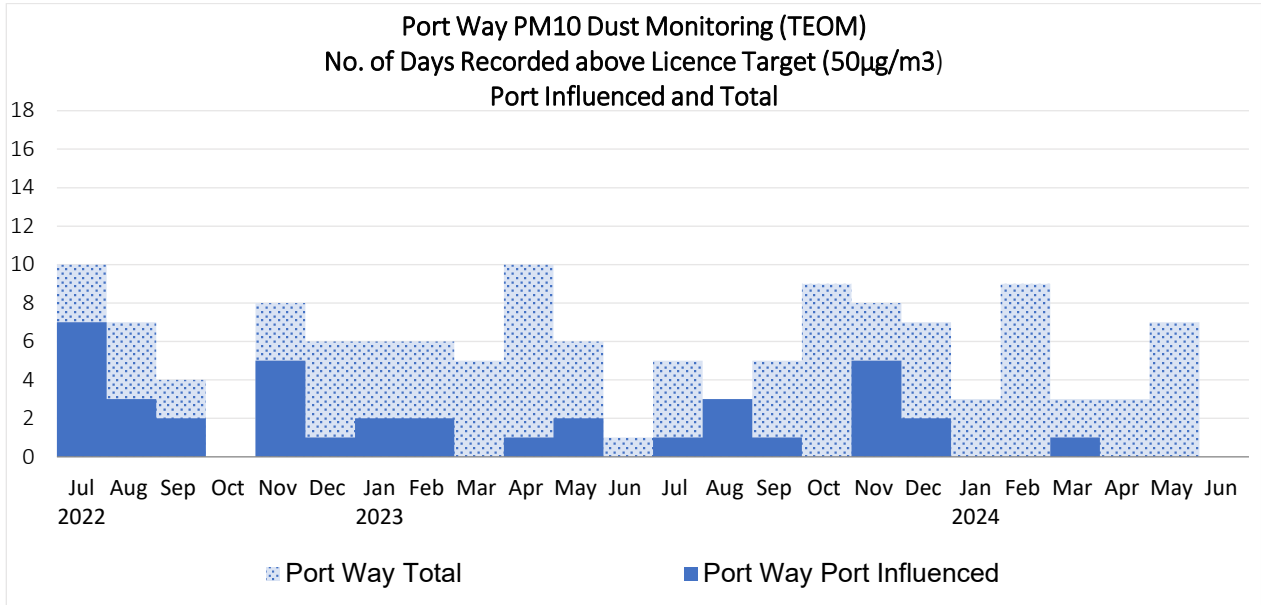
Figure 7 - Port Way – Number of days per month above 50µg/m³ – Port Influenced and Total

- Port Way (PW) observed a reduced number of days above $50 \mu\text{g}/\text{m}^3$, a reduction in average dust levels and a decrease in maximum dust levels was recorded.

Figures 7 through 11 present Port influenced, and total days per month above the licence target ($50\mu\text{g}/\text{m}^3$).

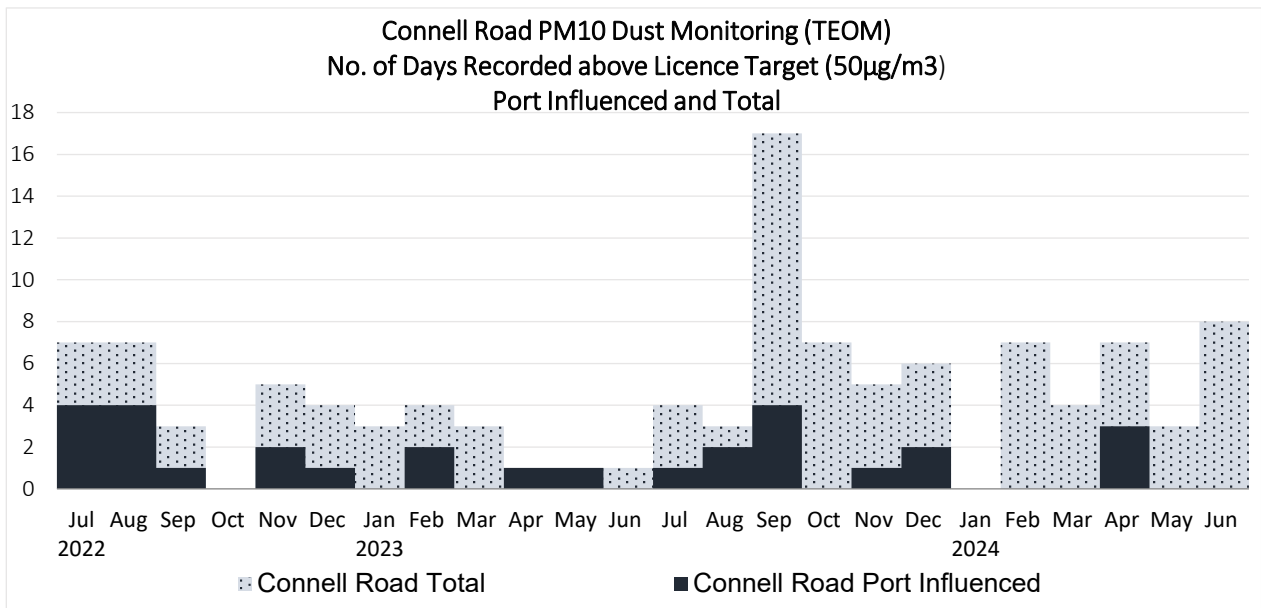
Figure 8 - Connell Road – Number of days per month above 50µg/m³ – Port Influenced and Total

- Connell Road (CR) observed a significant increase in the number of days above $50 \mu\text{g}/\text{m}^3$, an increase in average dust levels and a higher maximum dust level. Located within 5 meters of a breakwater and adjacent to a beach, it receives more background particulates from sea spray aerosols and wind-blown beach sand compared to other monitoring sites.

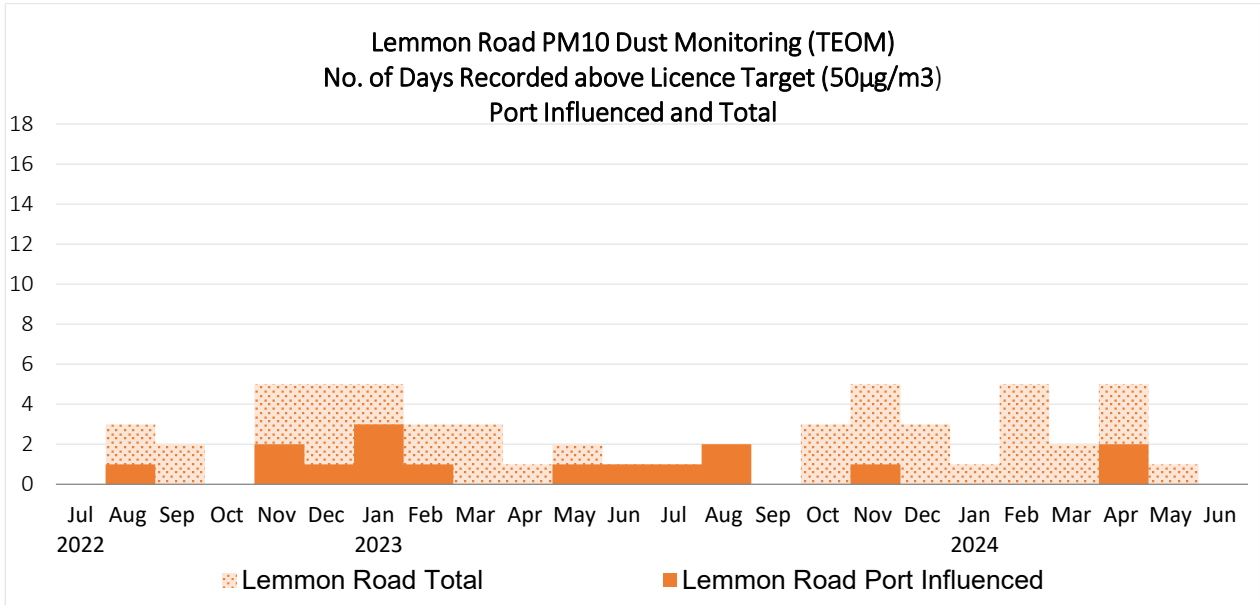
Figure 9 - Lemmon Road – Number of days per month above 50µg/m³ – Port Influenced and Total

- Lemmon Road (LR) observed a slight decrease in the number of days above $50 \mu\text{g}/\text{m}^3$, a reduction in average dust levels and a decrease in maximum dust levels recorded.

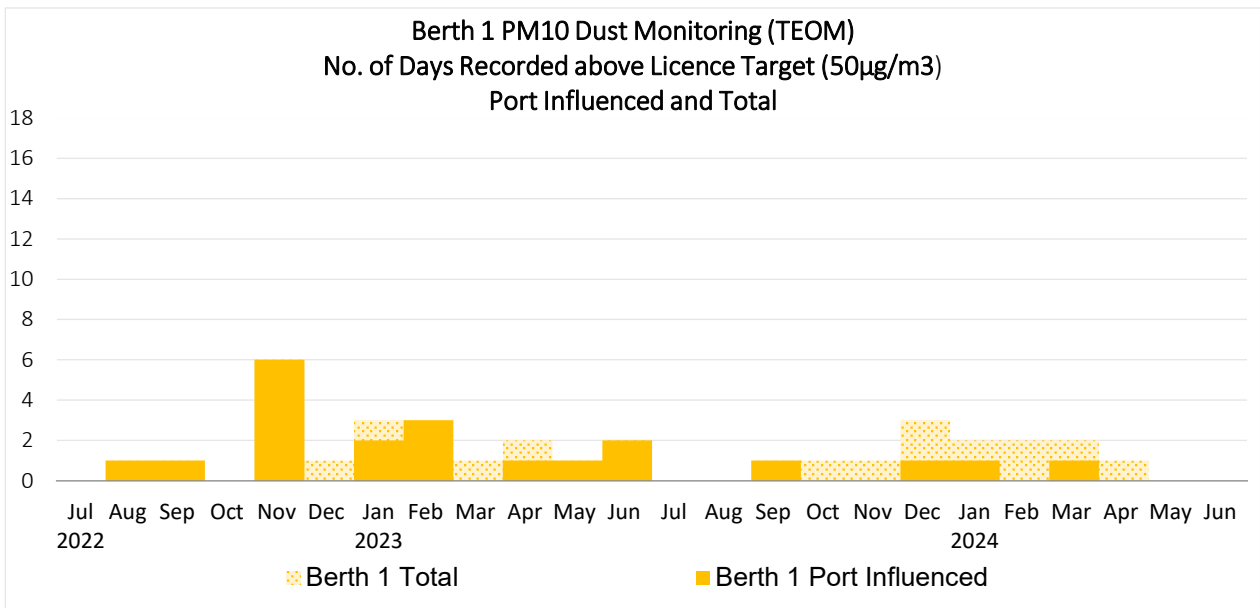
Figure 10 - Berth 1 – Number of days per month above 50µg/m³ – Port Influenced and Total

- Berth 1 (B1) situated within the commercial harbour observed the lowest number of days above $50 \mu\text{g}/\text{m}^3$ (13 days) the lowest average dust level and the lowest maximum dust level.

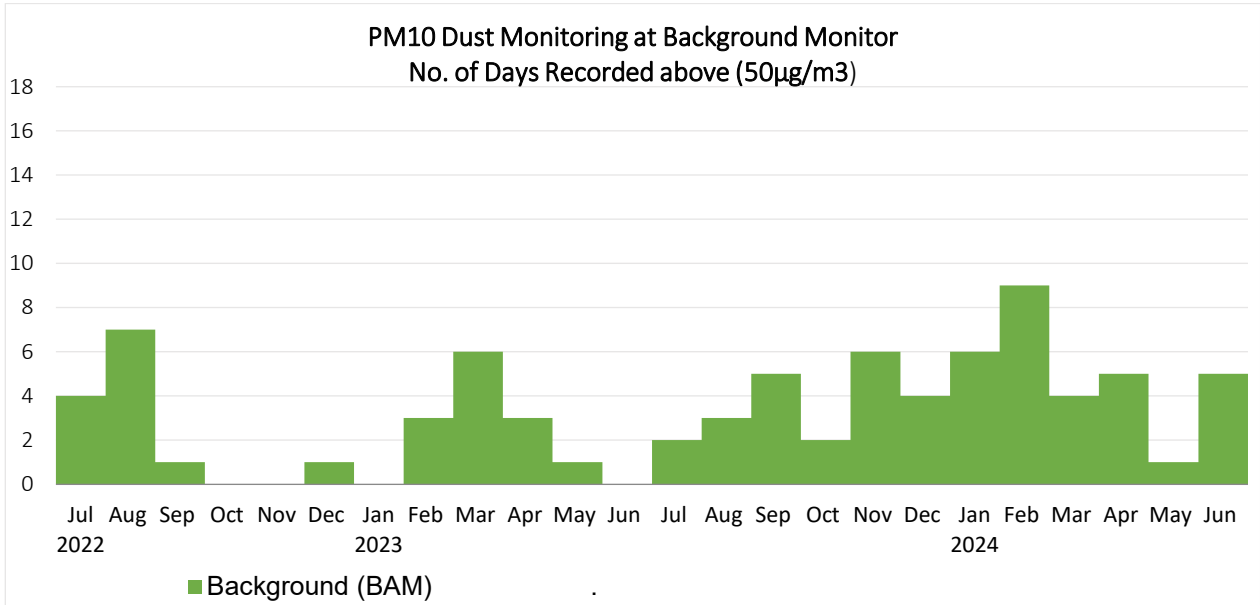
Figure 11- Background Monitor – Number of days per month above 50µg/m³

- Three out of five locations observed a decrease in the number of days where results exceeded the 50 µg/m³ as PM₁₀ daily target.
- The Background BAM (BB) recorded a substantial increase in the number of days above 50 µg/m³ with 52 days recorded, increasing from 26 days the previous year. Background average dust levels were also slightly higher than previous years.

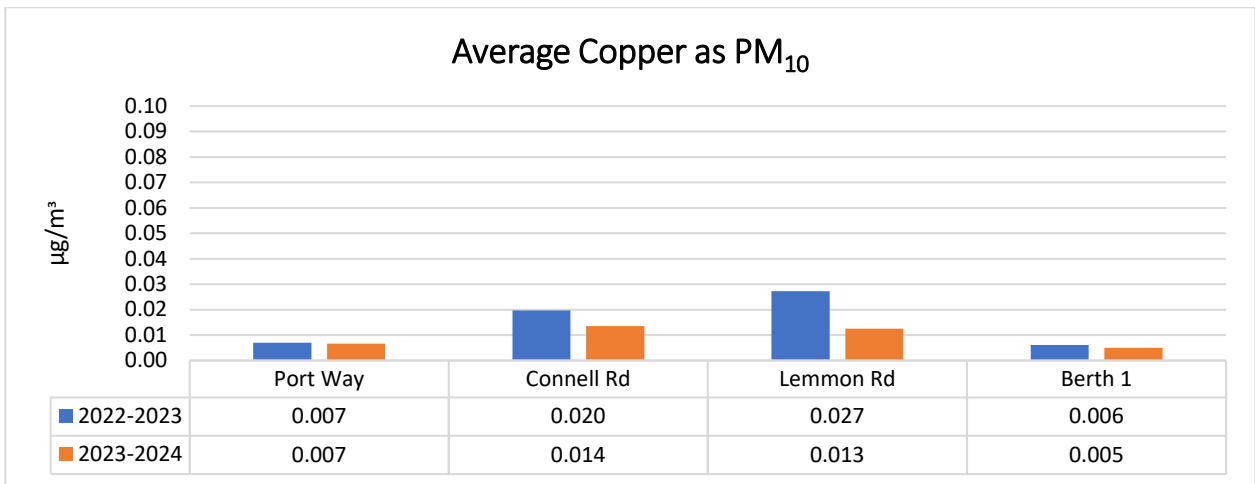
Figure 12 - HiVol Copper as PM_{10} - Monitoring Summary

There was a reduction of the average levels of copper in 2023/2024 measured across all monitoring locations compared to 2022/2023. The reduction in measured copper levels aligns with the migration of copper loading from Berth 4 to Berth 6. The last ship loaded with copper over Berth 4 was completed 16/12/2023. Figure 12 displays the annual average concentration of copper in HiVol samples for each monitoring location. Figure 13 displays each individual result for copper as PM_{10} in 2022/2023 and 2023/2024.

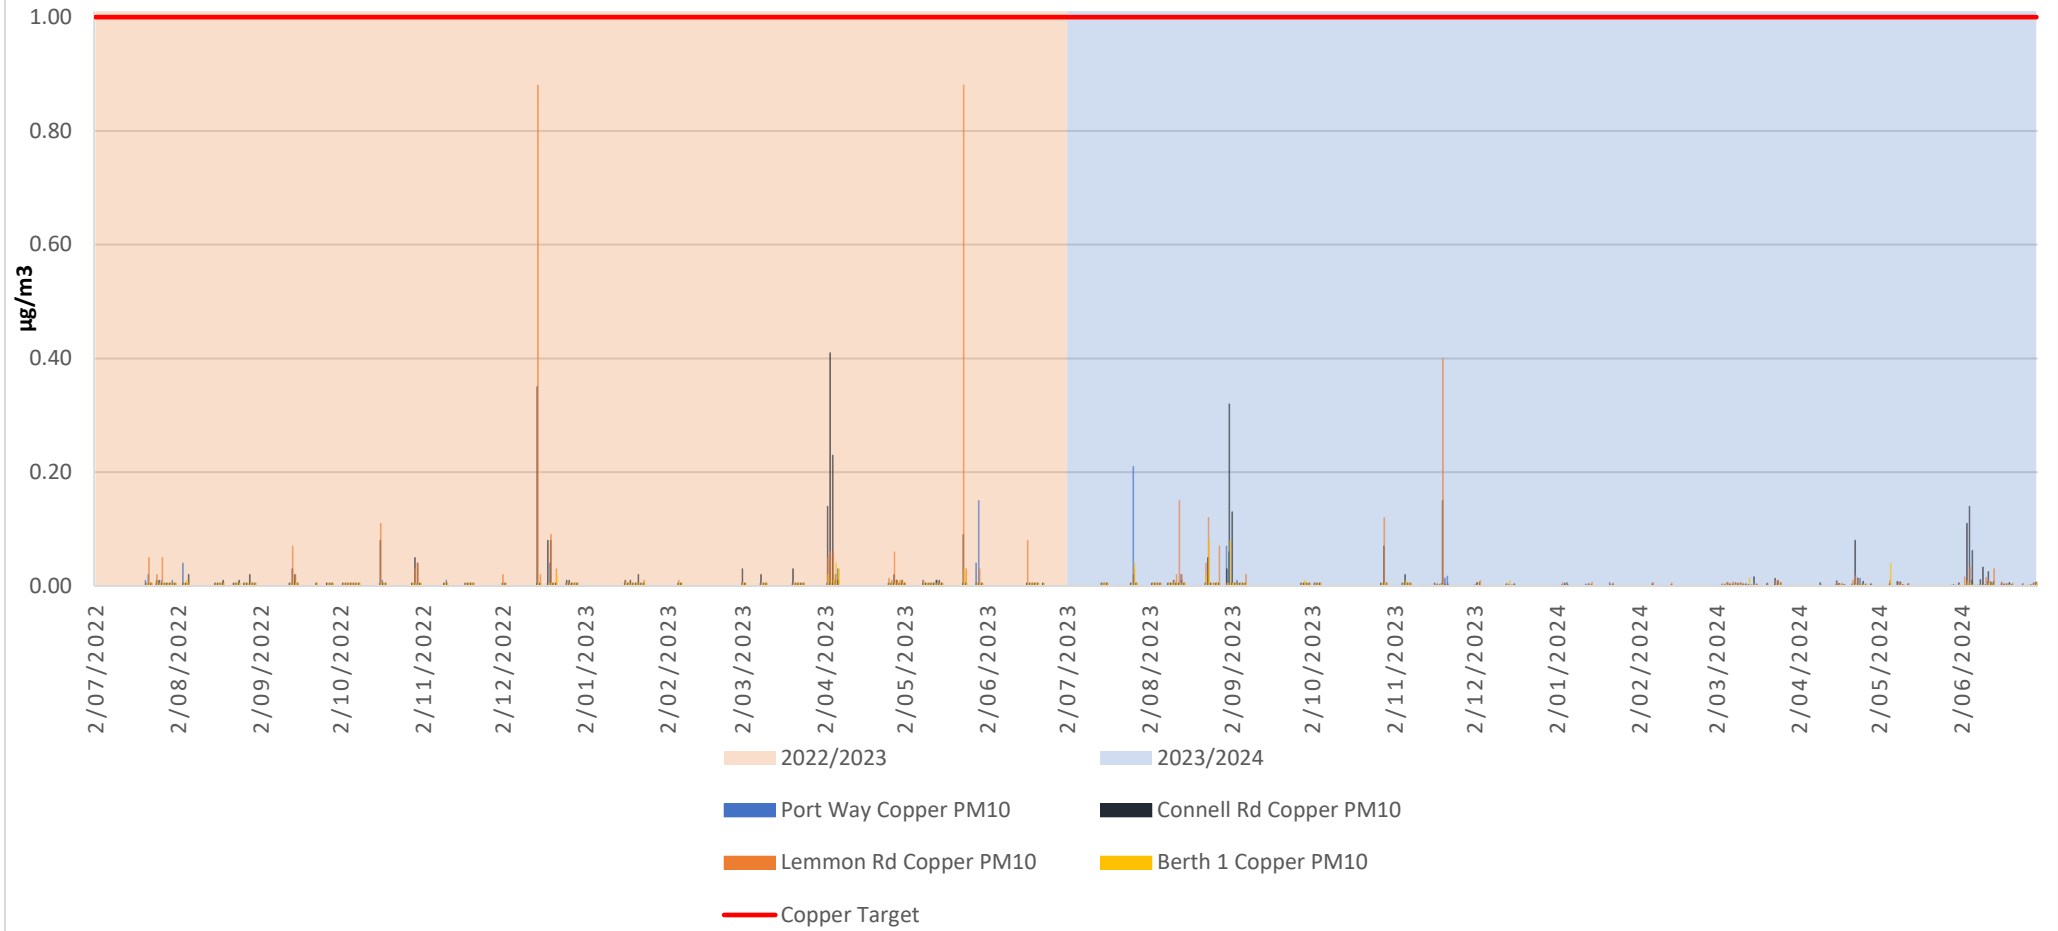
Copper as PM₁₀
Environmental Licence Target = 1.0 µg/m³

Figure 13 - 2022/2023 and 2023/2024 Copper Levels in Dust as PM₁₀

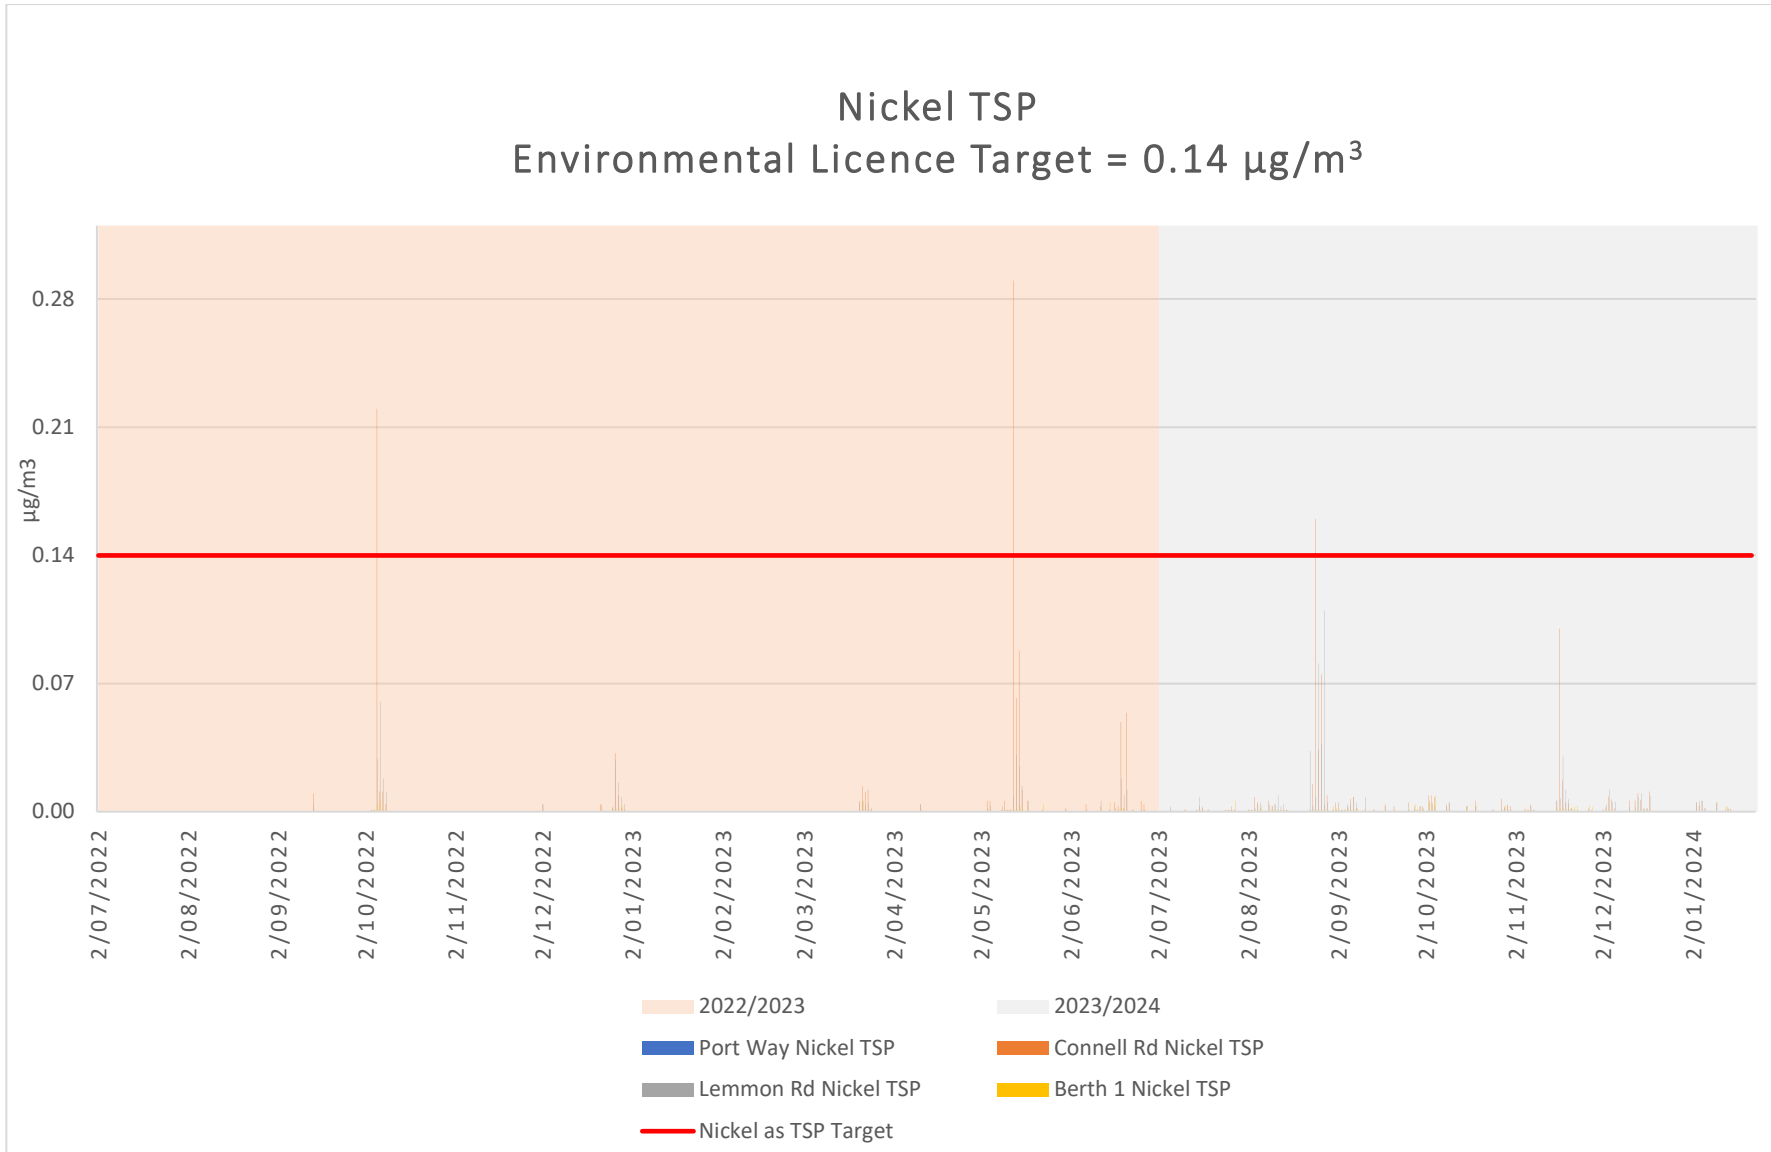
Figure 14 - 2022/2023 and 2023/2024 through to February Nickel Levels in Dust as TSP

An investigation of the exceedance was completed, and corrective actions implemented. The outcomes of the investigation were reported by MWPA to DWER on 13 October 2023. No exceedances in nickel have since occurred during any loading events on Berth 6.

Figure 17 displays each individual result for nickel as TSP in 2022/2023 and 2023/2024 through to February.

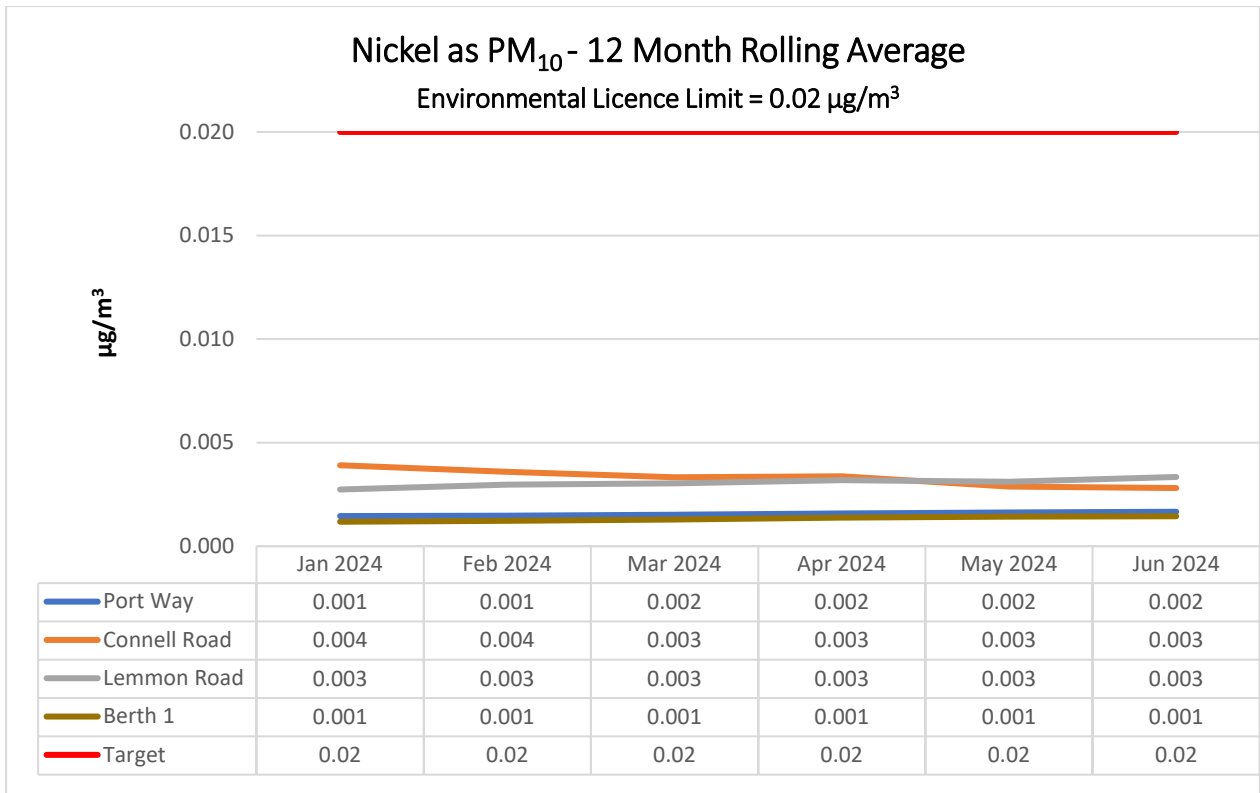
Figure 15 - Nickel as PM₁₀ 12 month rolling average

The 3-month rolling average for nickel as PM₁₀ remained well below the licence limit of 0.02 µg/m³ as shown on Figure 13. The target for nickel as PM₁₀ came into effect in January 2024.

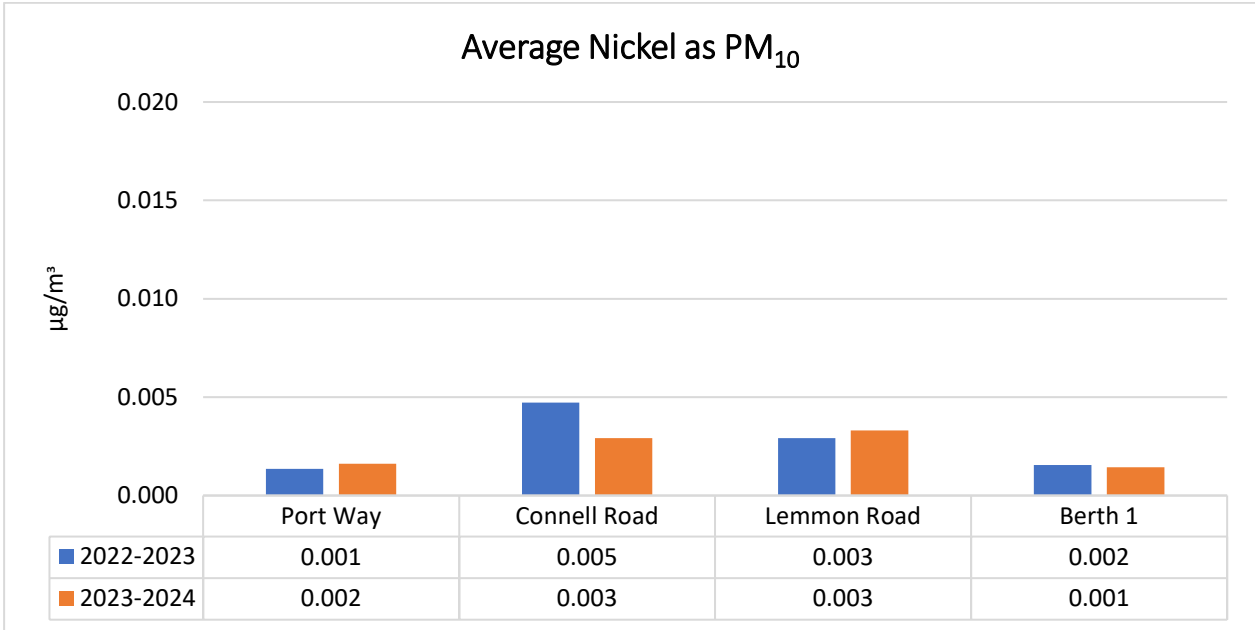
Figure 16 - HiVol Nickel – Annual PM₁₀ Average - Monitoring Summary

Average nickel as PM₁₀ levels remained very low across all monitoring sites, with slightly higher concentrations recorded at Connell Road and Lemmon Road compared to other monitors. Figure 16 displays the annual average concentration of nickel in HiVol samples for each monitoring location. Figure 17 displays each individual result for nickel as PM₁₀ in 2022/2023 and 2023/2024.

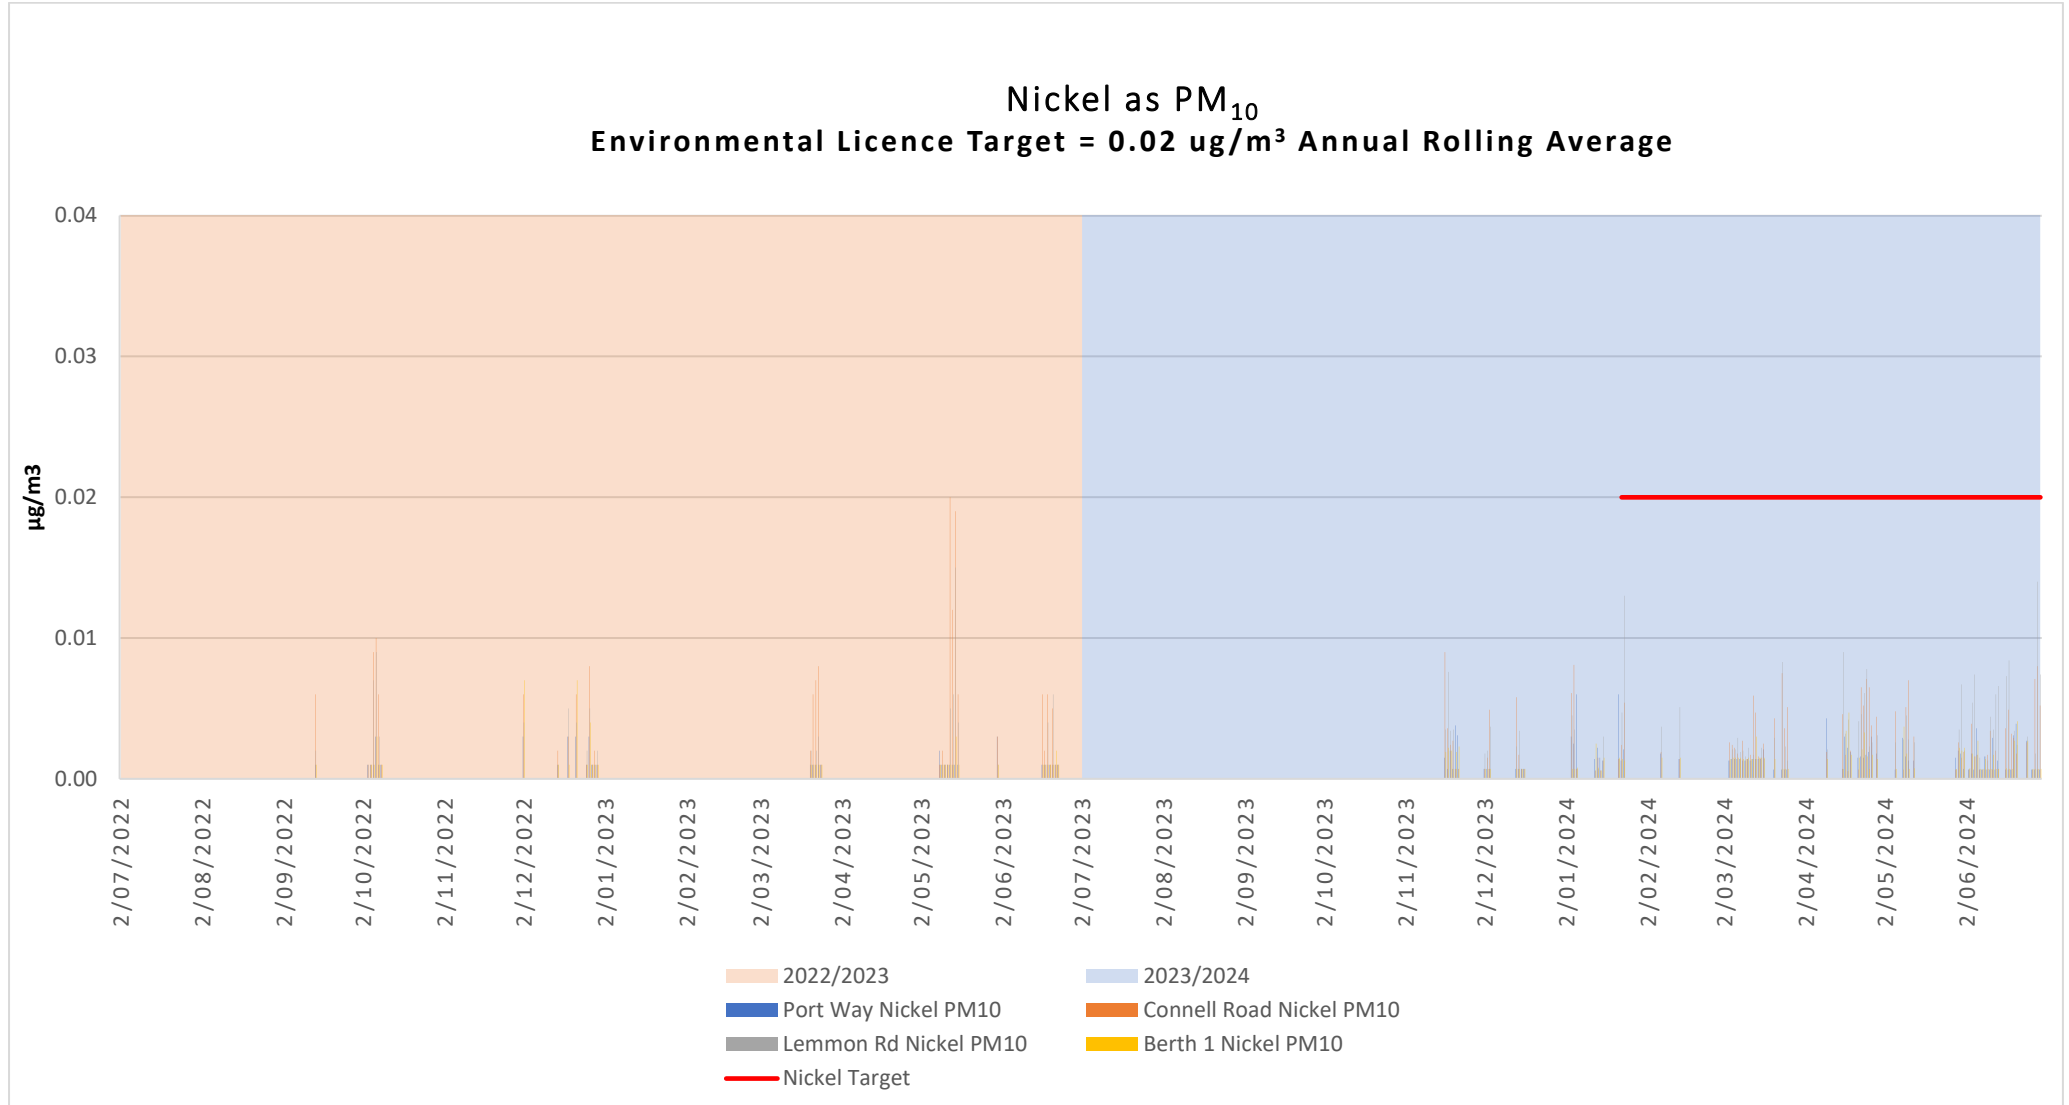
Figure 17 - 2022/2023 and 2023/2024 Nickel Levels in Dust as PM₁₀

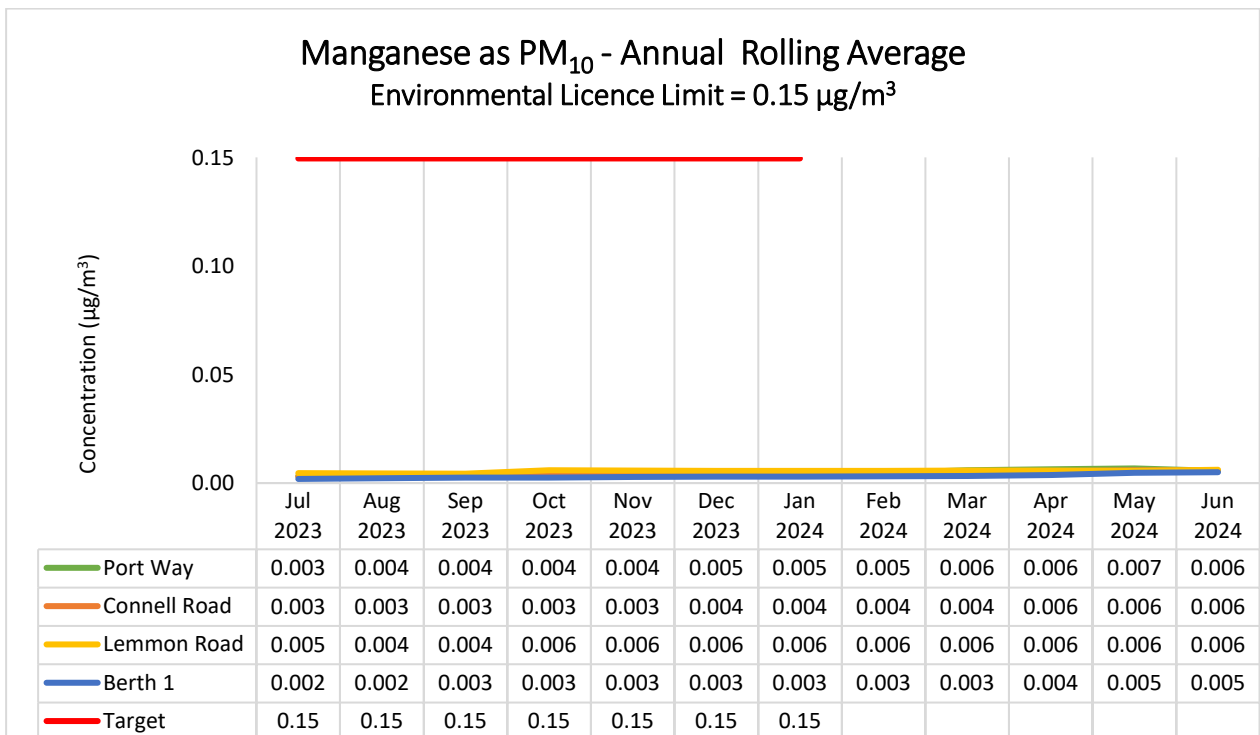
Figure 18 - Annual Rolling Average Manganese as PM₁₀

In January 2024, the licence target for manganese changed from 0.15 µg/m³ as an annual rolling average to 0.15 µg/m³ as a 24-hour average. Figure 18 displays the annual rolling average for manganese as PM₁₀. All recorded levels are below the licence target level at the time of 0.15 µg/m³.

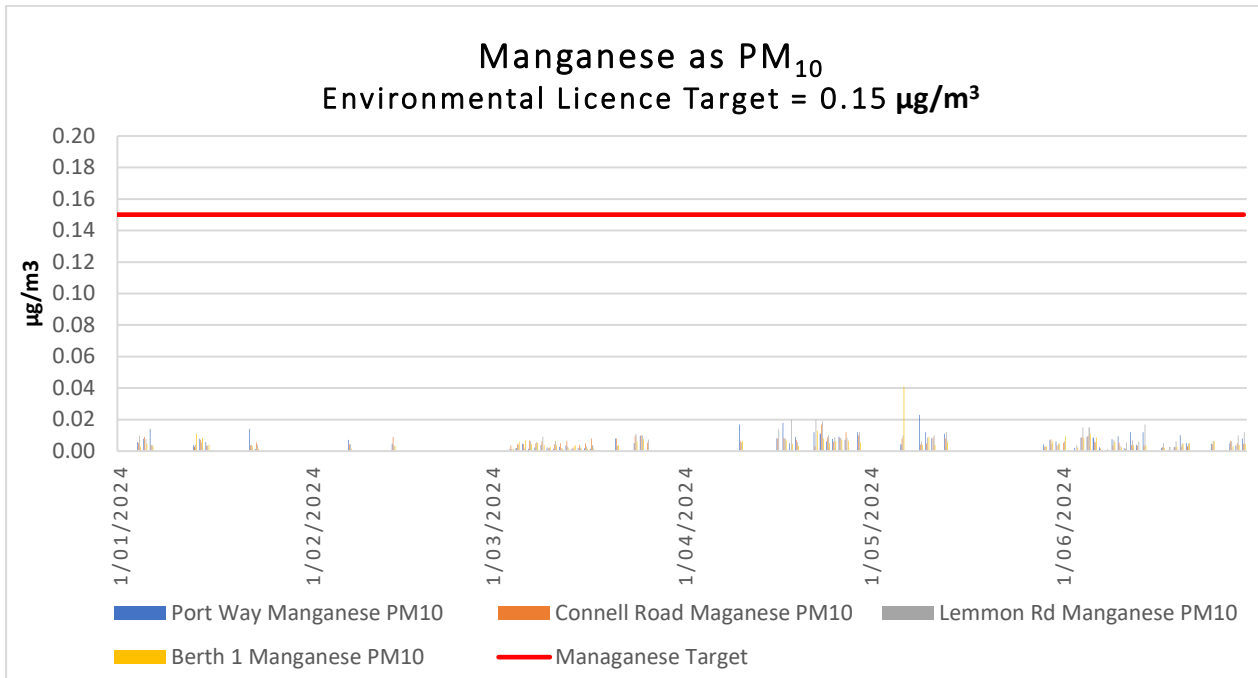
Figure 19 - 2024 Manganese Levels in Dust as PM₁₀

From January 2024 to July 2024, there were no exceedances of the new licence target level for manganese (0.14 µg/m³) 24 hour average. Figure 19 displays manganese concentrations recorded as PM₁₀.

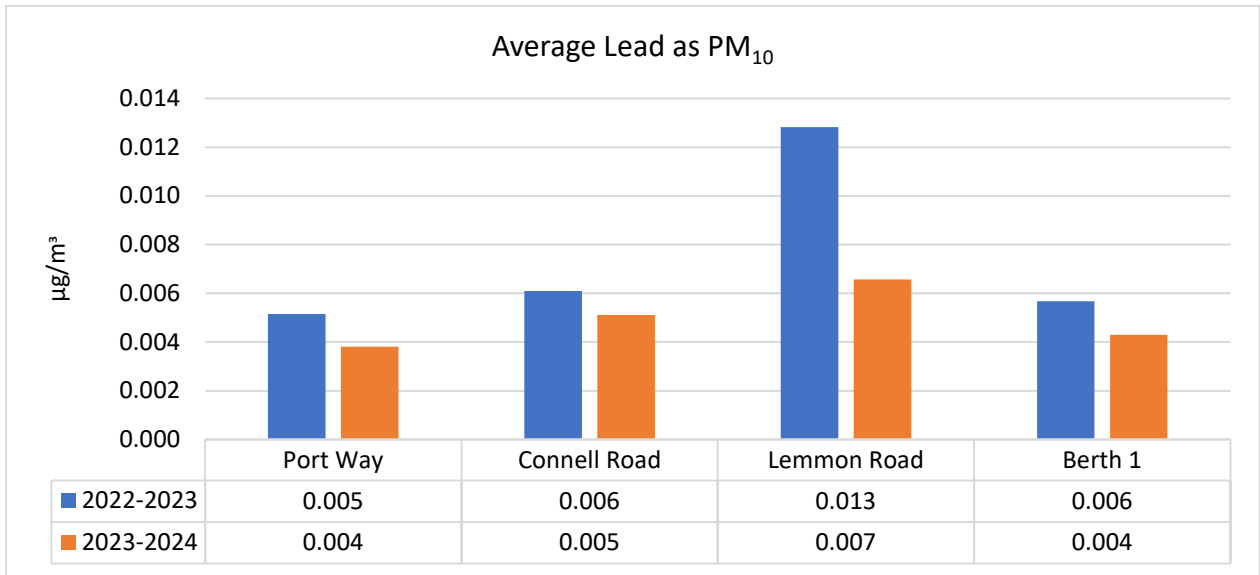
Figure 20 – Annual Average HiVol Lead as PM₁₀

During the reporting period, there were no exceedances of the licence target level for lead recorded (0.5 µg/m³). Figure 20 displays the annual average concentration of lead in HiVol samples for each monitoring location. Figure 21 displays each individual result for lead as PM₁₀ in 2022/2023 and 2023/2024.

Transitioning lead concentrate loading from conveyor and shiploader at Berth 4 to rotainer loading at Berth 6 is expected to have contributed to the reduction in average lead levels recorded at all monitors.

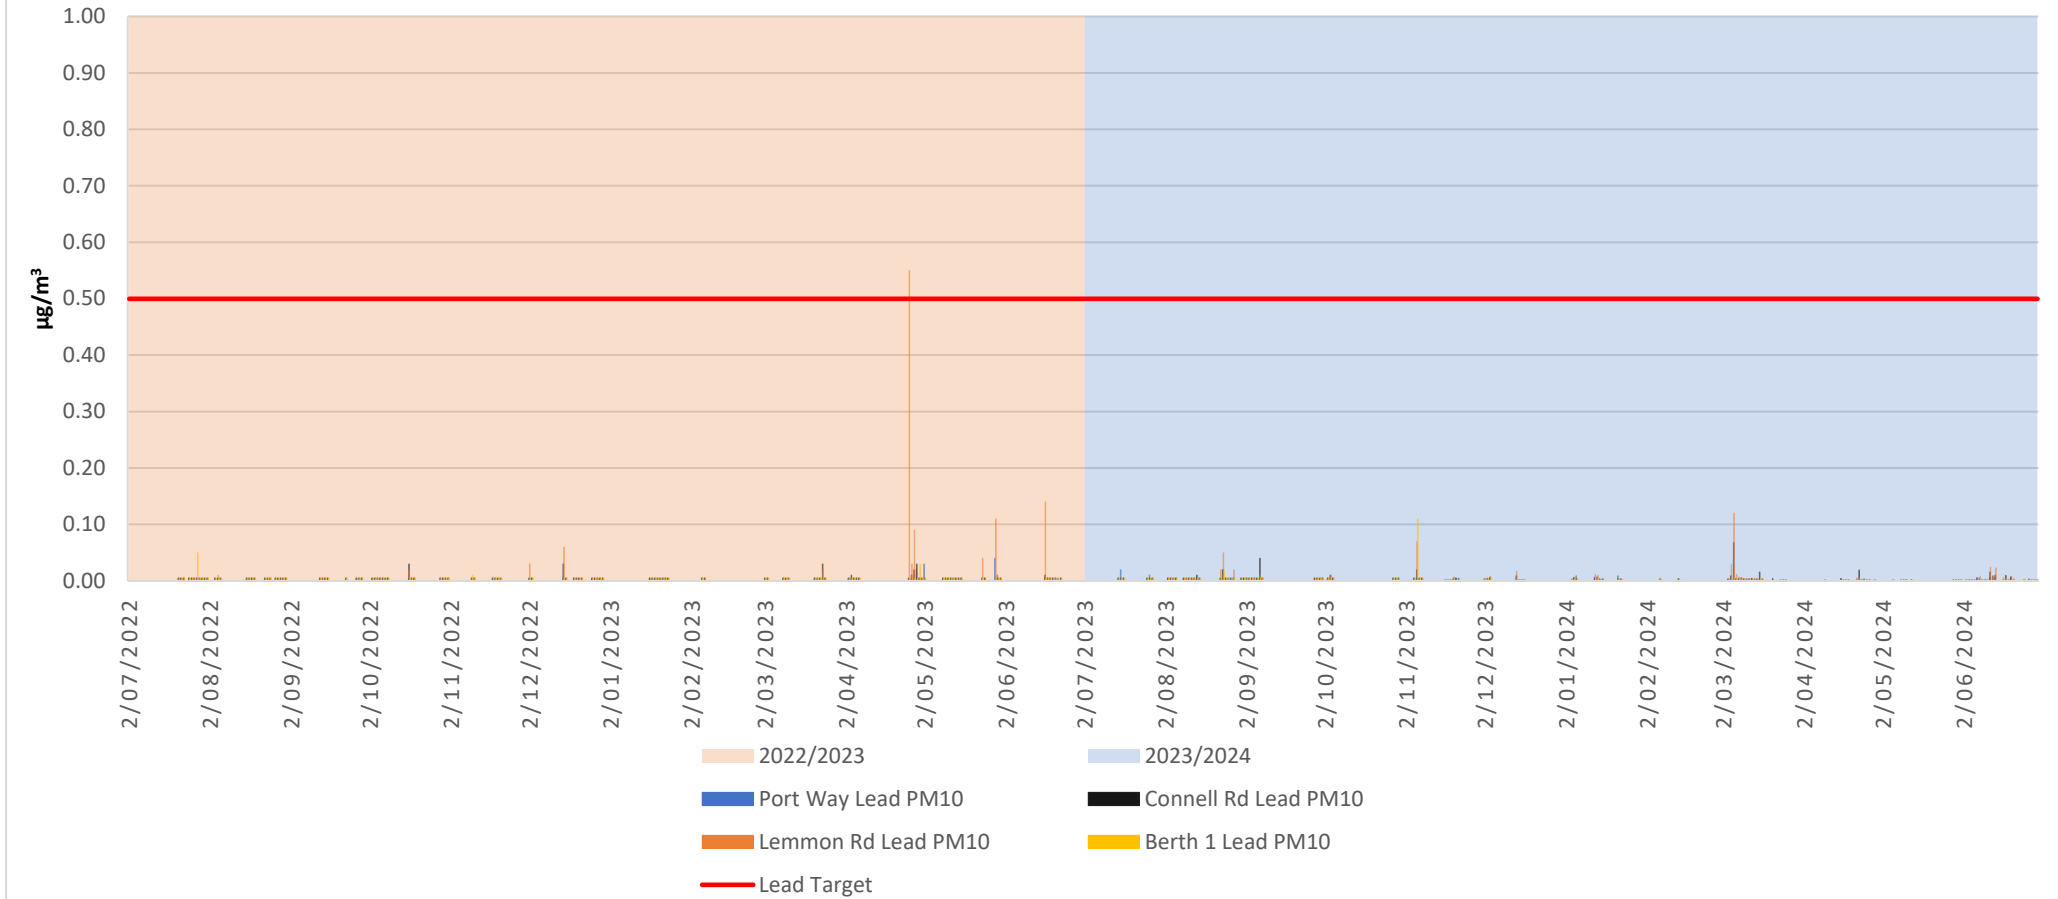
Lead as PM₁₀
Environmental Licence Target = 0.5 µg/m³

Figure 21 - 2022/2023 and 2023/2024 Lead Levels in Ambient Air as PM₁₀
