AUGUST 2024

Annual Environmental Report

Prepared By:
Mid West Ports

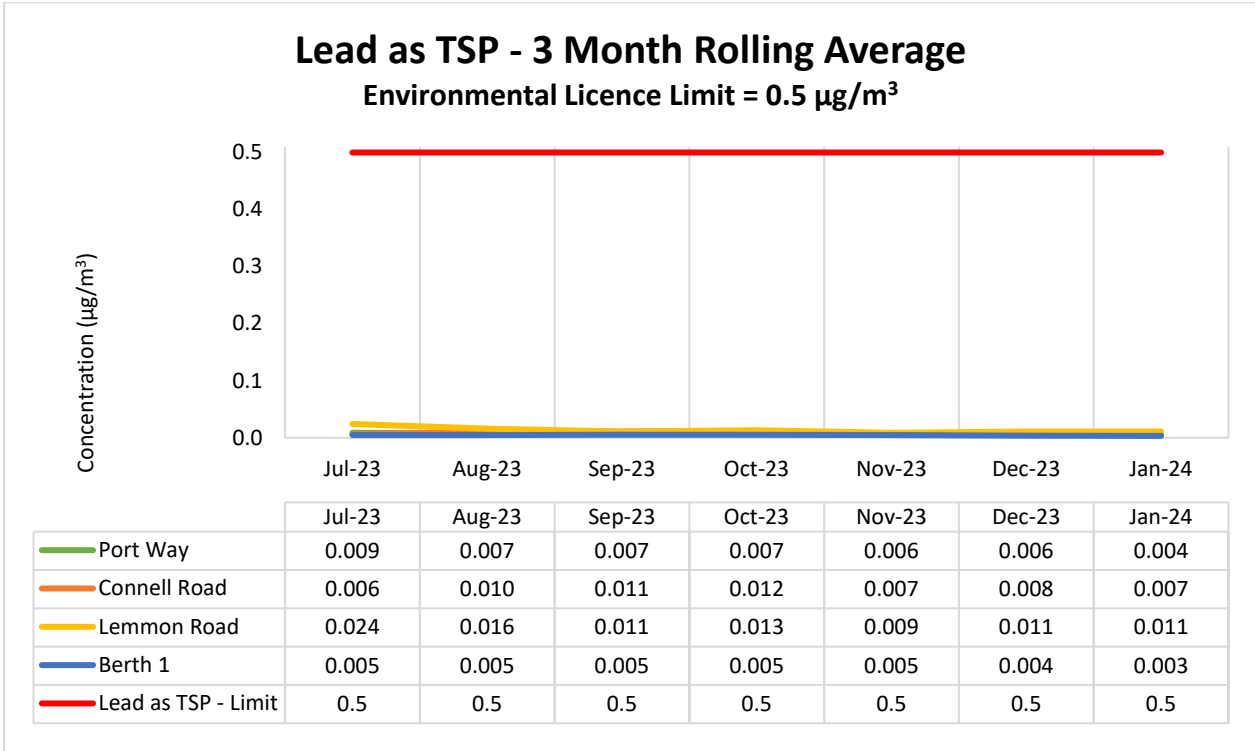
Figure 22 - Lead as TSP 3 month rolling average

The 3-month rolling average for lead as TSP stayed well below the licence limit of 0.5 µg/m³ as shown on Figure 22. The requirement to sample lead as TSP was removed from the licence in January 2024.

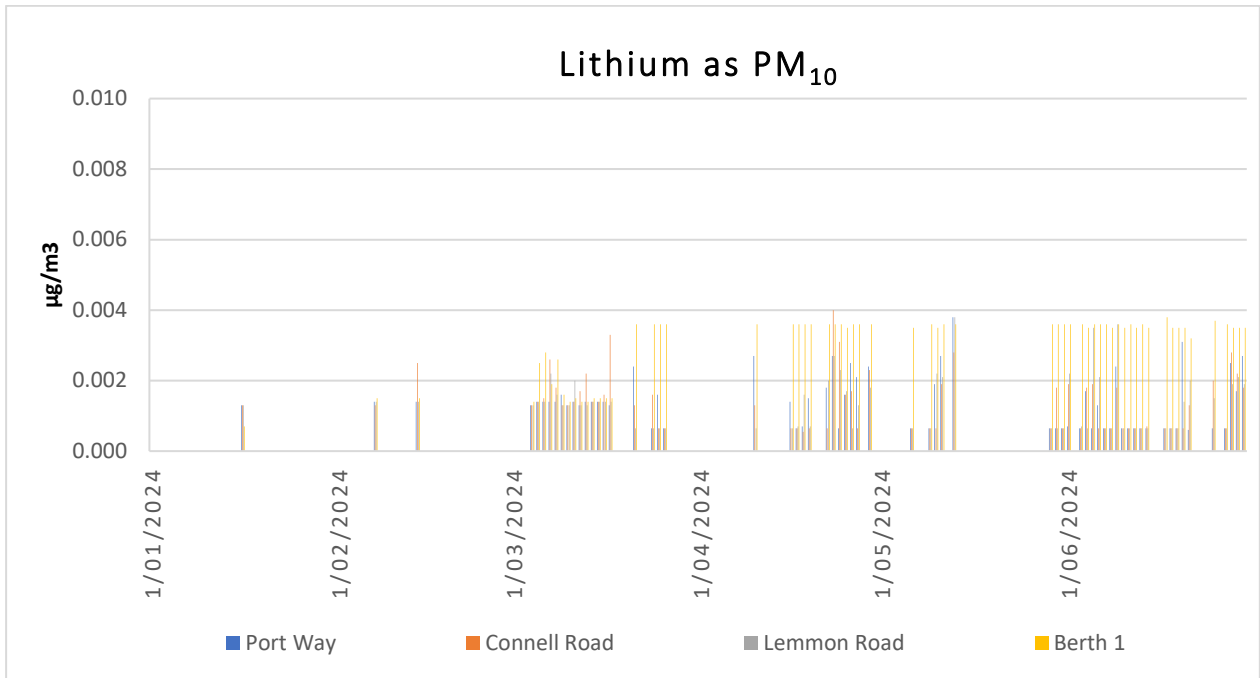
Figure 23 - Lithium Levels in Ambient Air as PM10

In January 2024, the Port received approval to export lithium direct shipping ore (DSO) and spodumene concentrate. The amendment included a requirement to monitor lithium as PM₁₀ (no target stipulated). There were no shipments of spodumene or lithium DSO in the 2023/2024 financial year, with loading expected to begin in 2024/2025. Figure 23 displays each individual result for lithium as PM₁₀ in 2024.

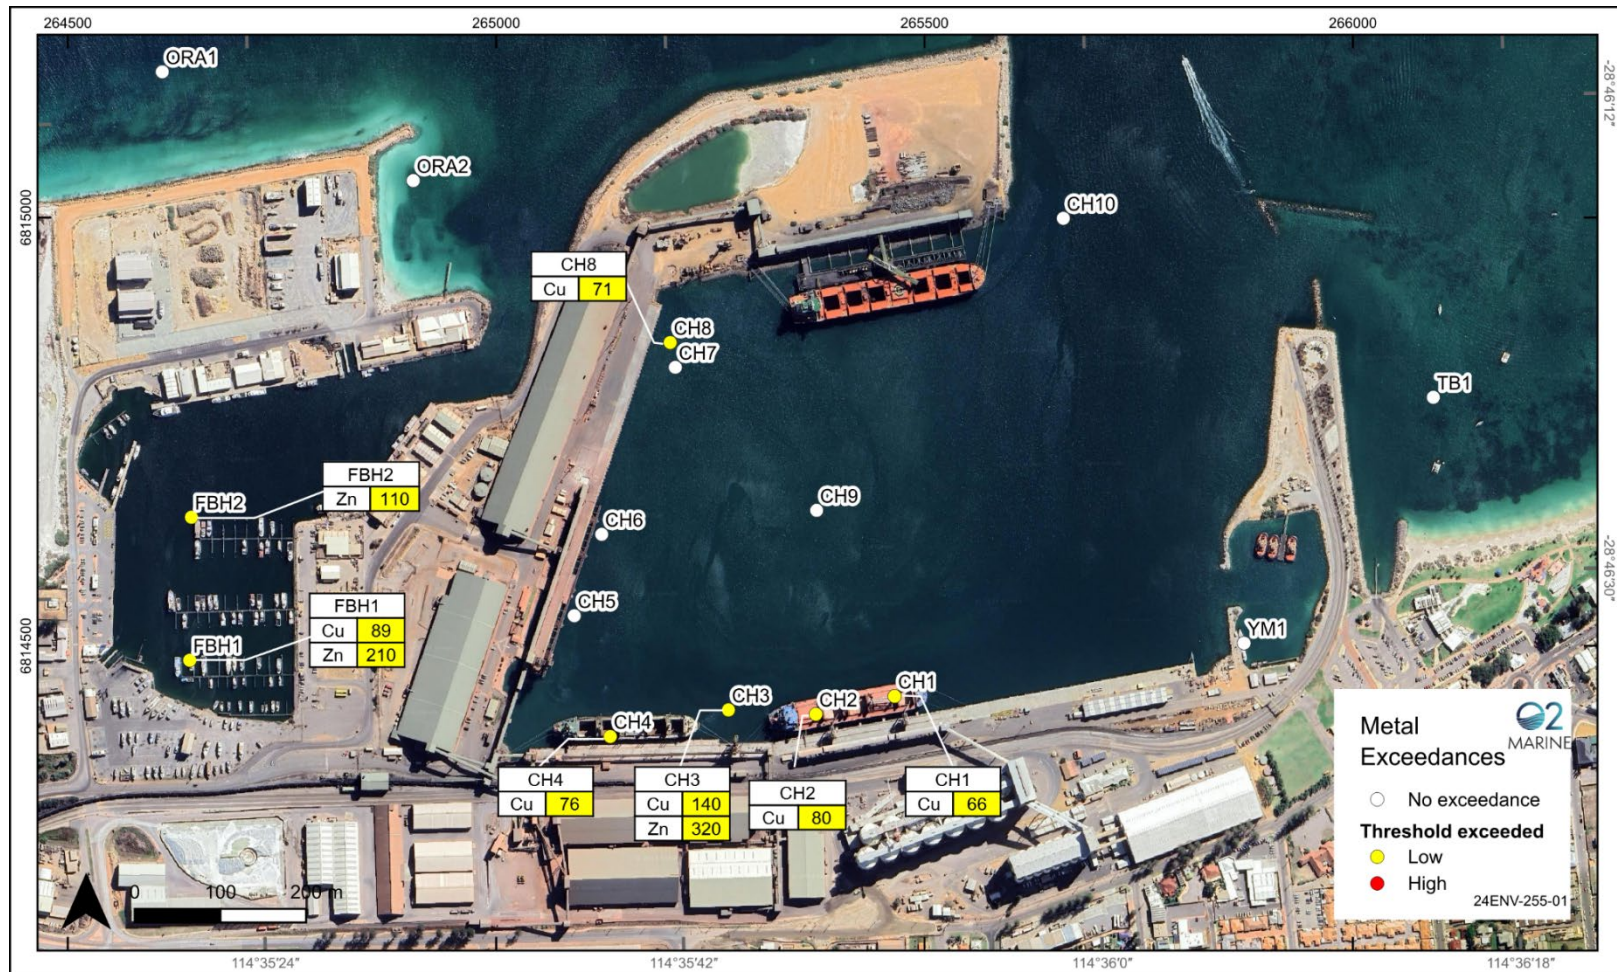
Figure 24 - Geraldton Port 2024 Sediment Sampling Locations and Metal Concentration Exceedances

Figure 24 shows metal concentrations (mg/kg) and exceedances of ANZG (2018) guideline values. Guideline values exist for arsenic, cadmium, copper, lead, mercury and nickel. No ANZG guideline values exist for iron, aluminium or vanadium.

An overview of the 2024 exceedances recorded above default guideline values (DGV) and the upper guideline values (GV-High) for metals where ANZG 2018 guideline values exist, is presented spatially in Figure 24.
